The Art and Science of Lightning Protection

Martin A. Uman

Martin A. Uman University of Florida

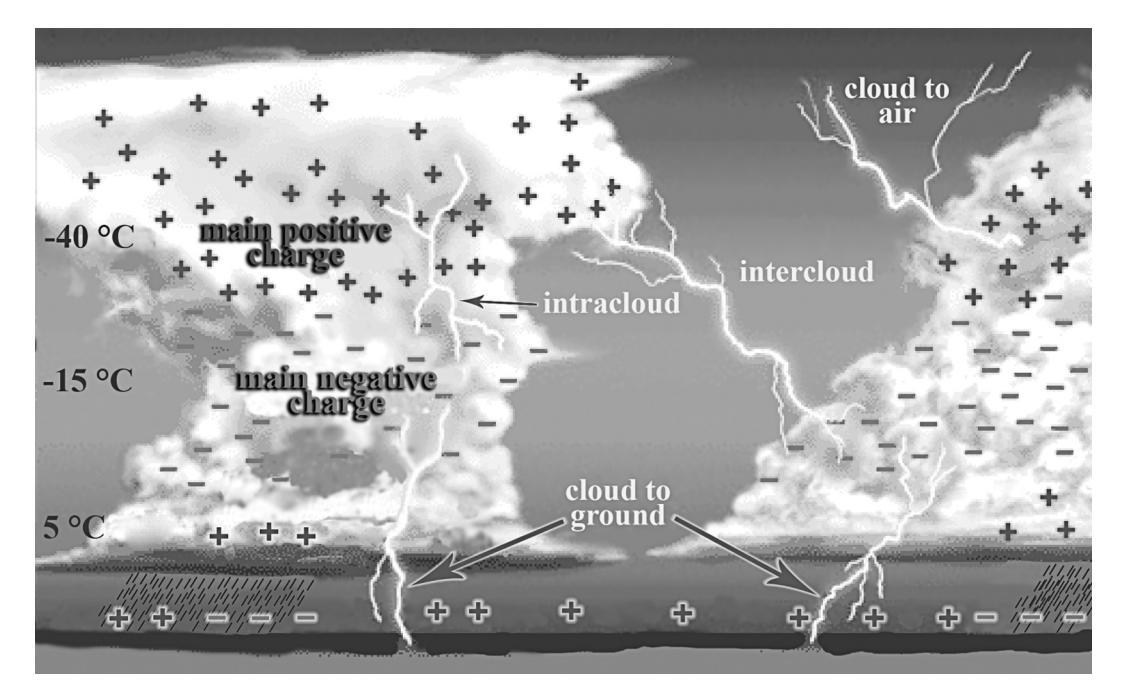
Fig. 1.3 The charge structure of two simple isolated thunderclouds and some of the locations where lightning can occur. Adapted from *Encyclopedia Britannica Online*, Lightning (2007) (see http://search.eb.com/eb/article-9048228).

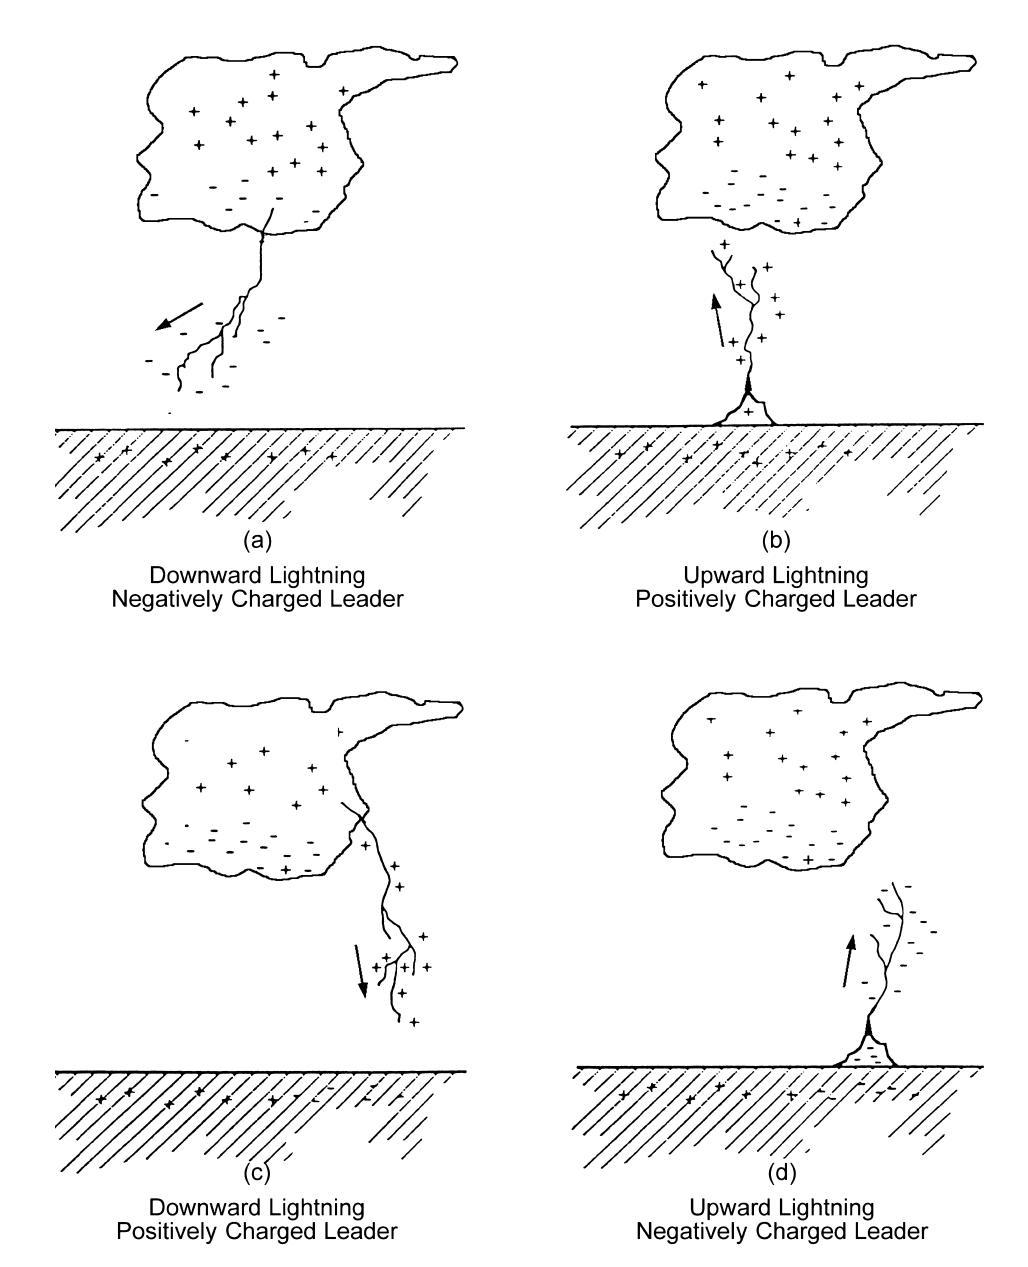
Fig. 1.4 The four types of cloud-to-ground lightning flashes as defined from the direction of leader propagation and the charge on the initiating leader. Adapted from Berger (1978).

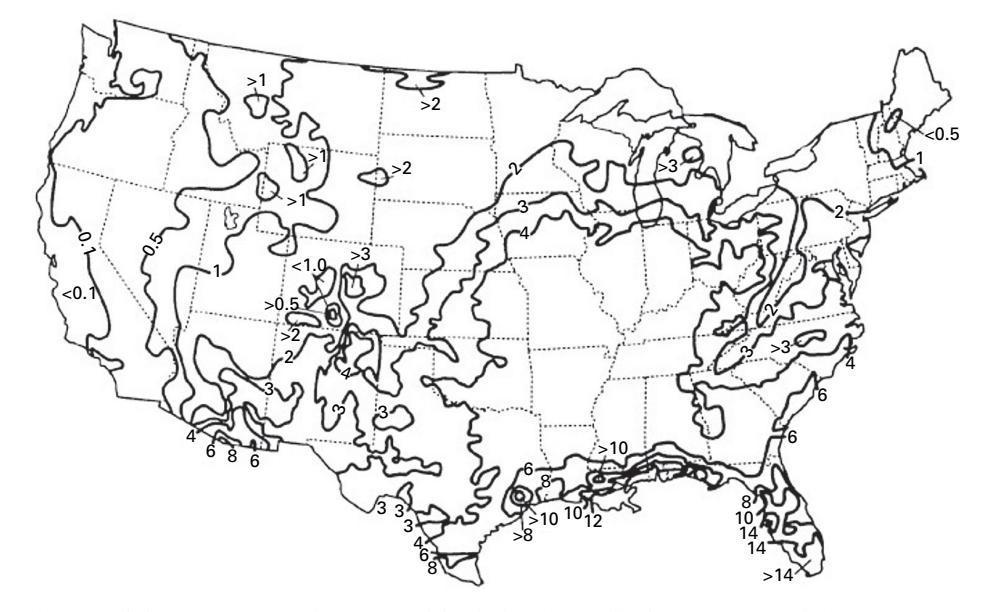
Fig. 1.5 A map of the average cloud-to-ground flash density (in flashes per square kilometer per year) in the continental United States from 1989 through 1998. Courtesy of Vaisala, Inc.

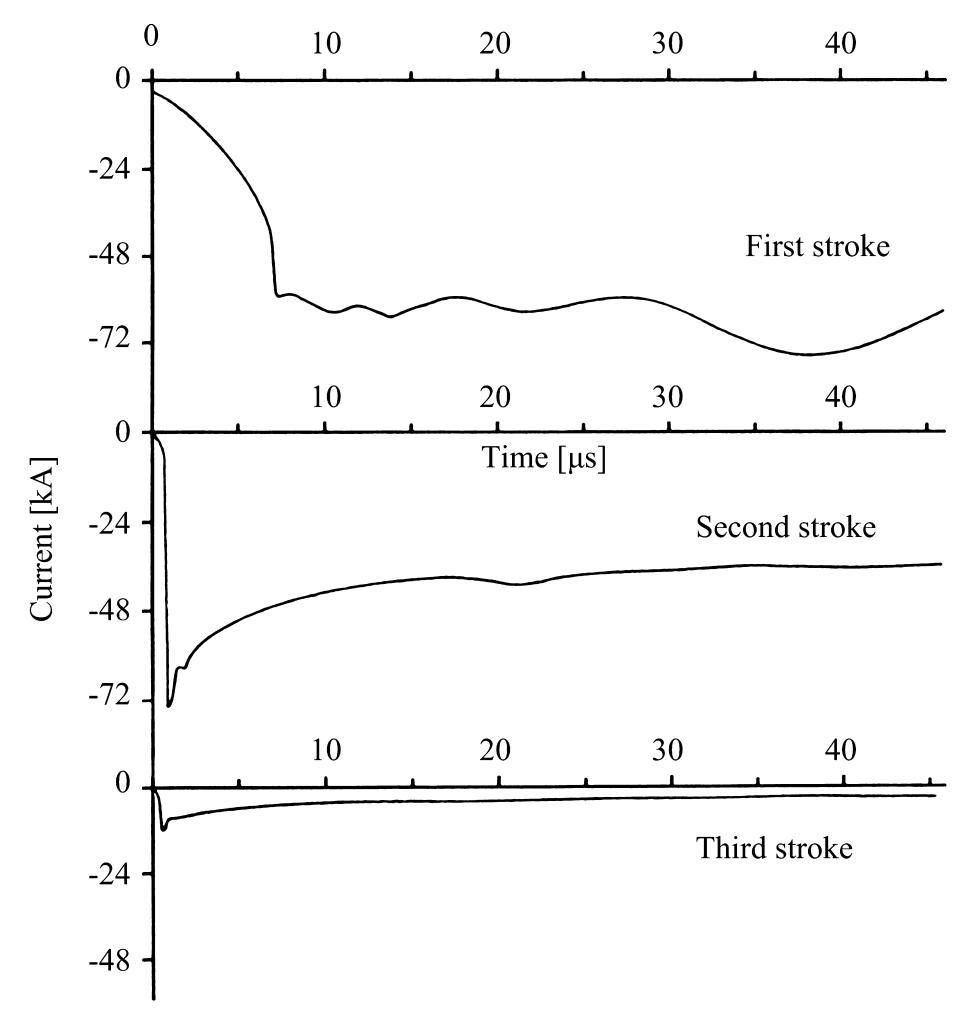
Fig. 1.9 Return stroke current observed at ground for a first stroke and two subsequent strokes lowering negative charge to a 60 m tower standing on flat ground in South Africa. The first two strokes are unusually large. Adapted from Eriksson (1978).

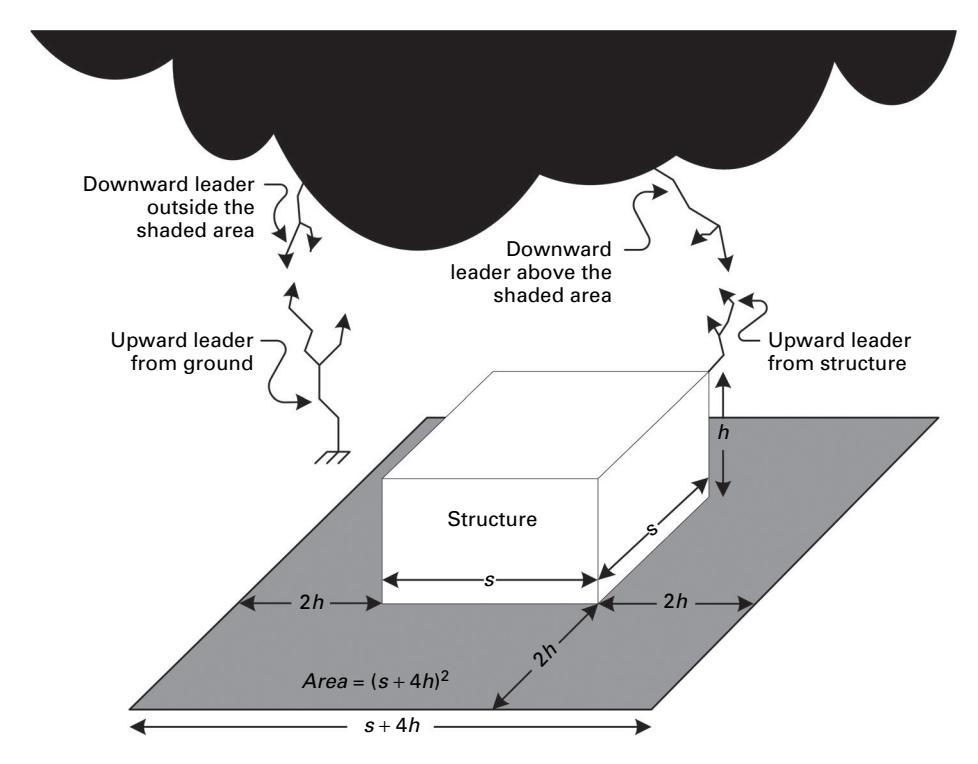
Fig. 1.12 A drawing illustrating the equivalent collective area on the ground, shown shaded, for a small structure.

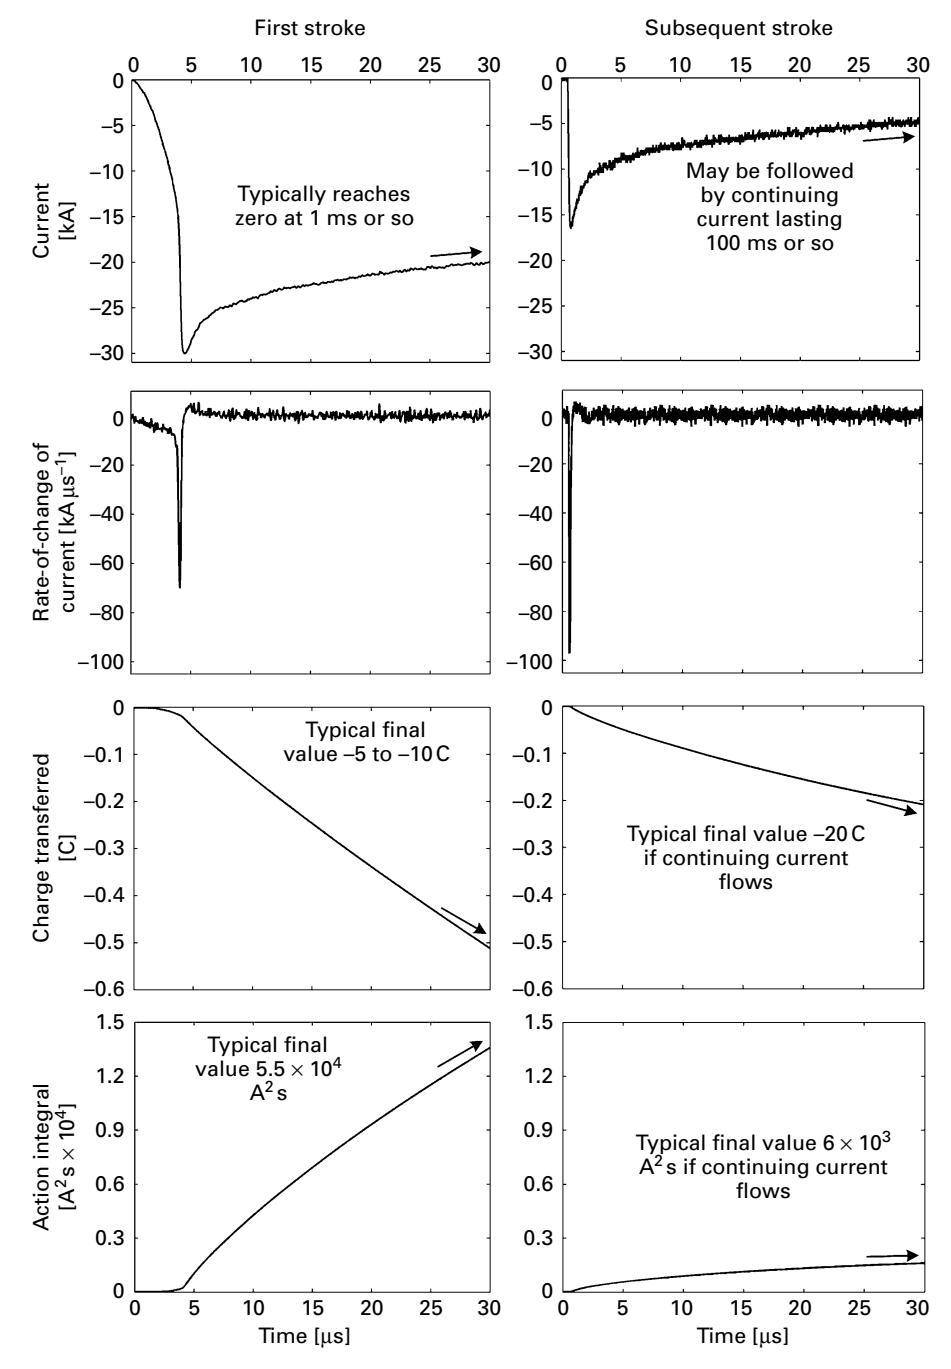
Fig. 2.1 Features of the current waveform of a lightning first and subsequent return stroke transferring negative charge to ground. These are hand-drawn curves representing typical values found in the lightning literature.

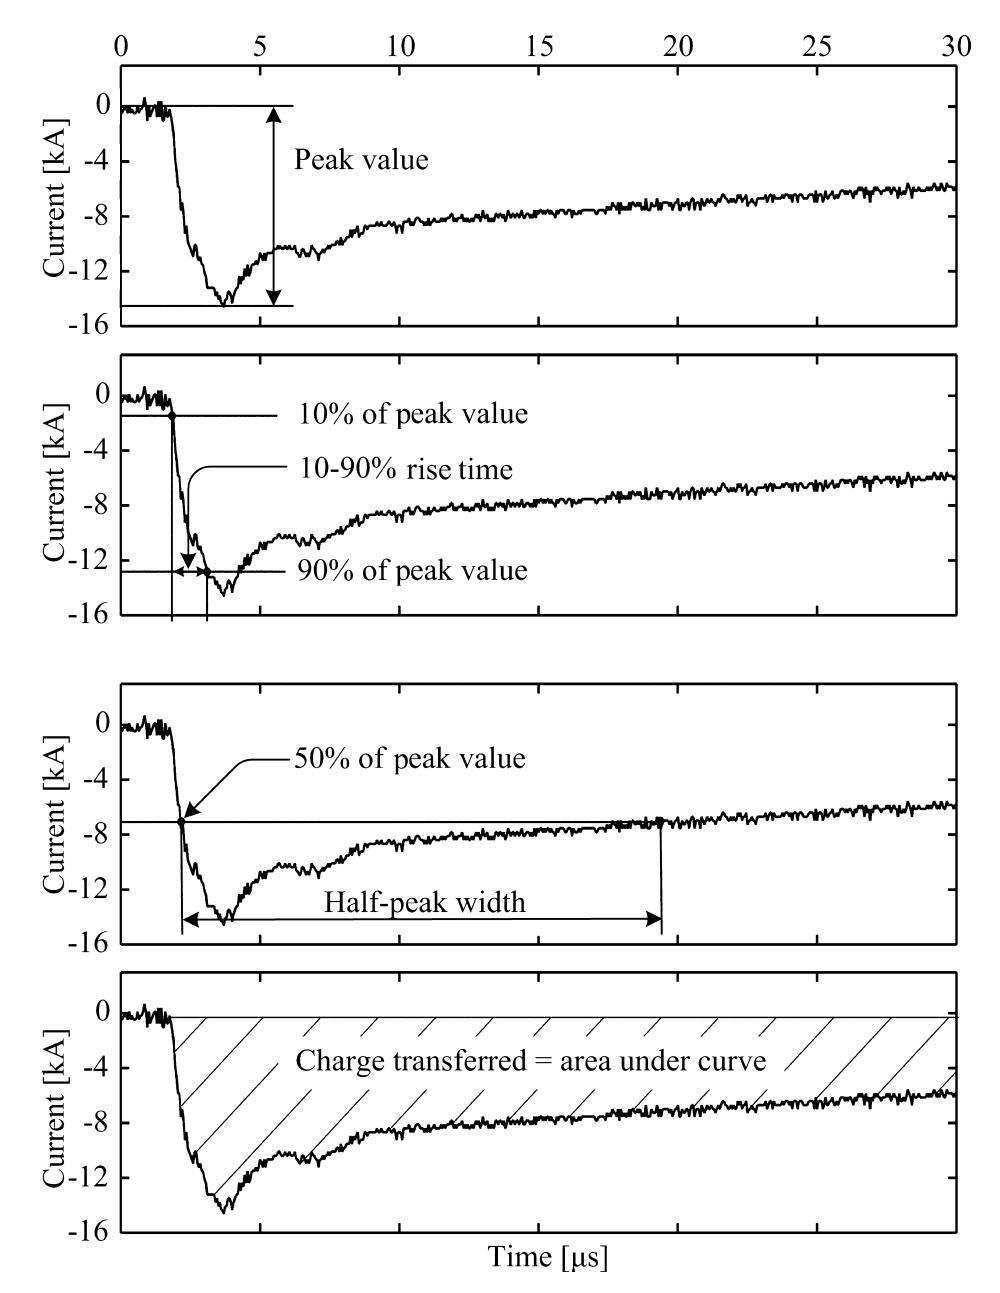
Fig. 2.2 Definitions of the most common return stroke parameters: peak value, 10–90 percent risetime, half-peak width, and charge transferred (area under current vs. time curve). The current waveform is that of a triggered lightning stroke (see Section 13.2). Triggered strokes are thought to be similar, if not identical, to subsequent strokes (strokes following the first stroke) in natural lightning.

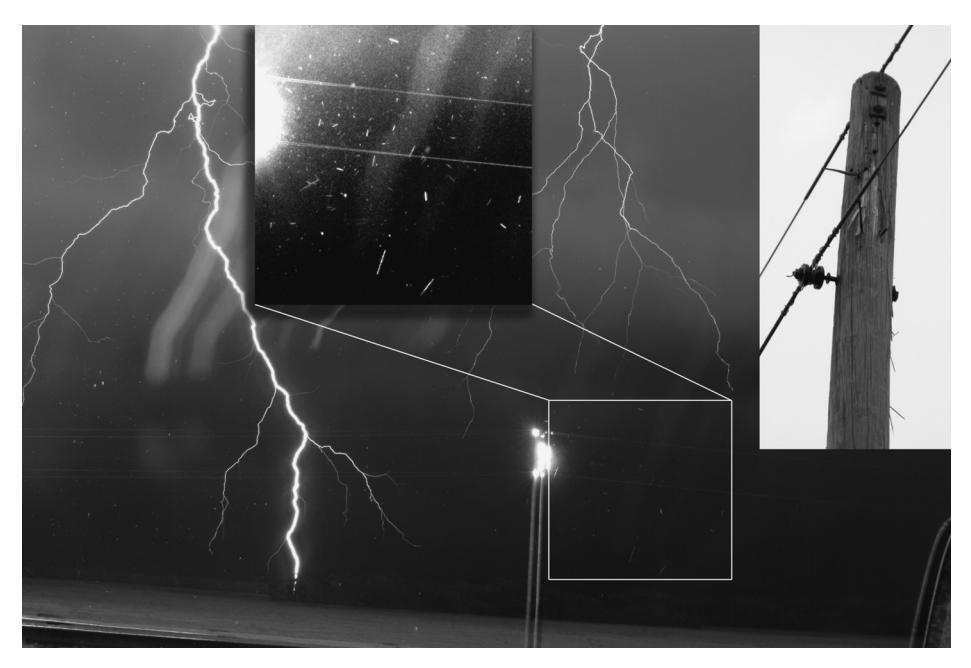
Fig. 2.3 Photograph of a lightning-caused flashover on a 12 kV single-phase power line near Shiloh, Tennessee. Photograph by Bryan S. Gross.

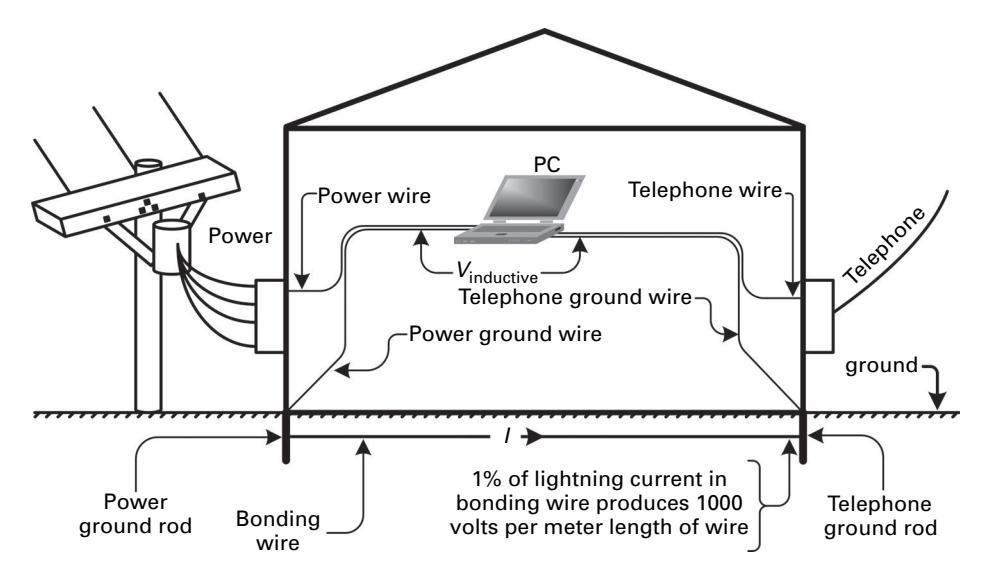
Fig. 2.4 Illustration showing how deleterious inductive voltages can be produced by a lightning strike on or near a structure with physically separated but electrically bonded grounding points for power and telephone services.

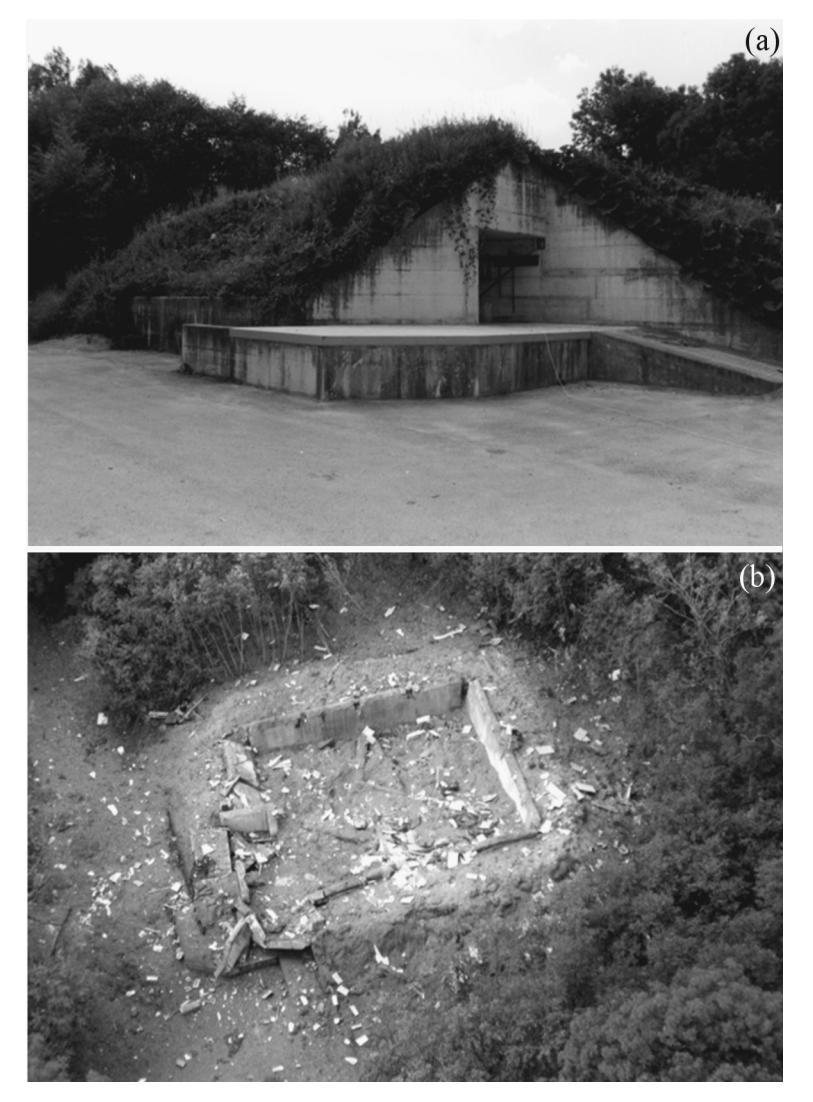
Fig. 2.5 A concrete explosives storage facility that was struck by lightning, (a) before and (b) after. Courtesy of Marvin Morris.

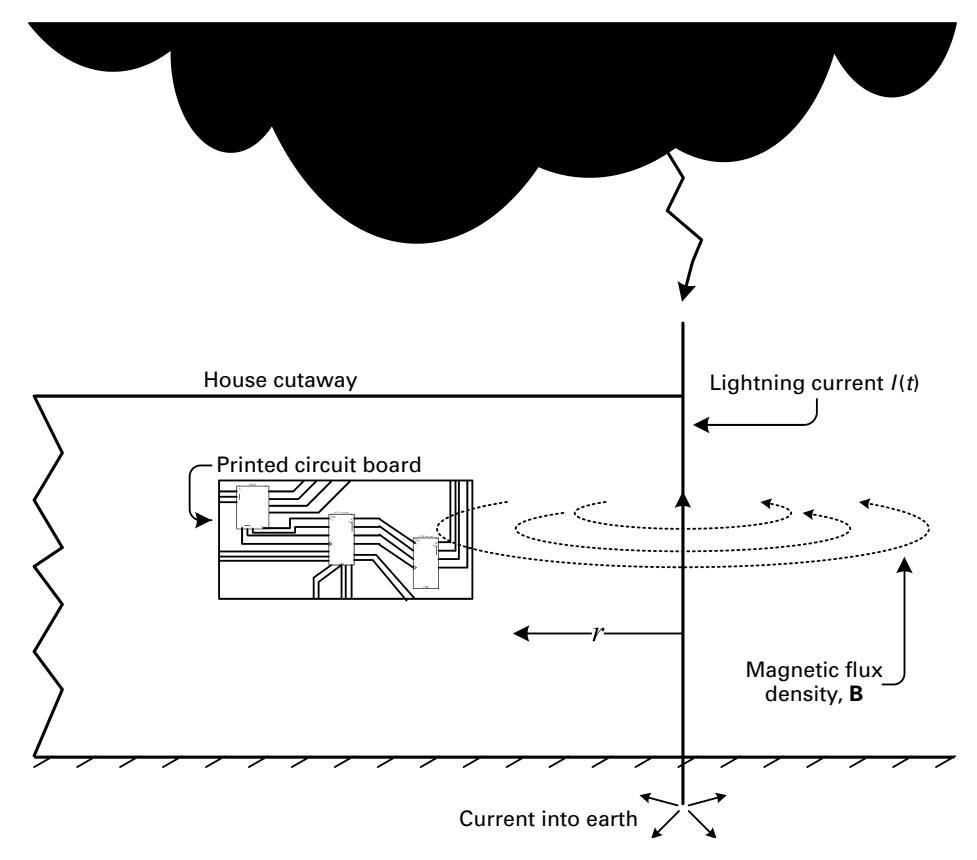
Fig. 2.8 Illustration of magnetic coupling to a circuit board from lightning current in the down conductor of a lightning protection system.

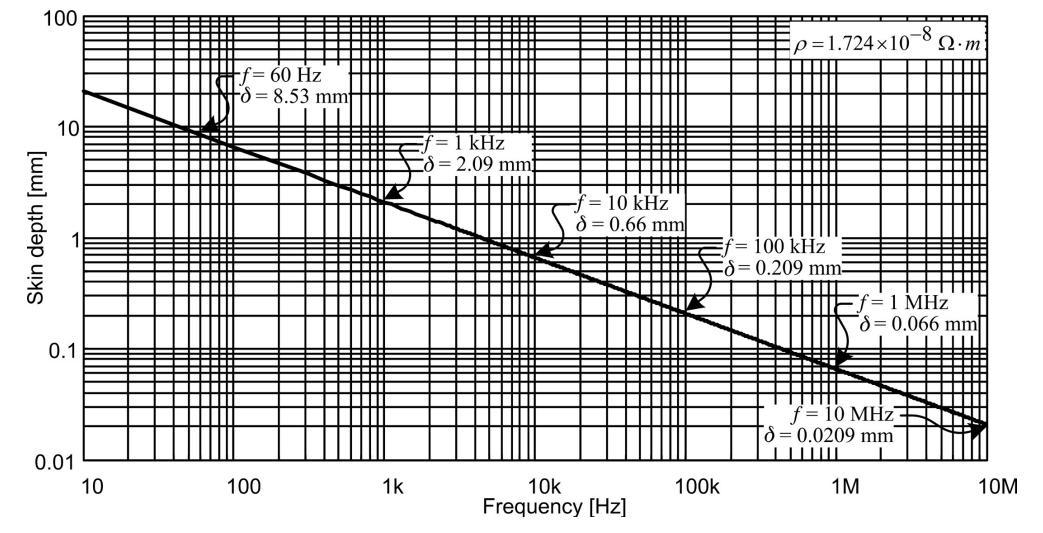
Fig. 3.1 Skin depth vs. frequency for copper, plotted on a log-log scale.

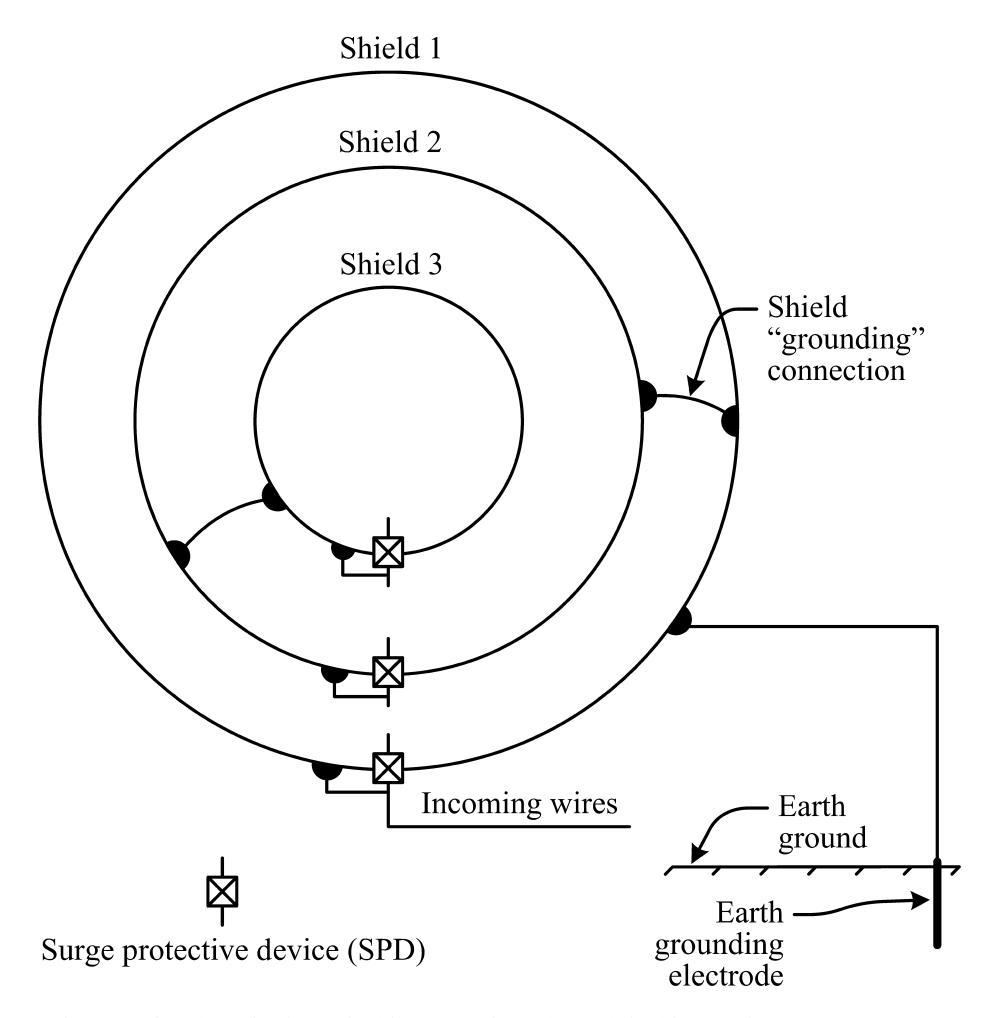
Fig. 3.2 Schematic drawing of a three-shield system of topological shielding with transient protection to provide optimum protection from the deleterious effect of lightning currents and fields. The highest degree of protection is found inside shield 3. Even higher degrees of protection can be achieved by nesting additional shields within shield 3.

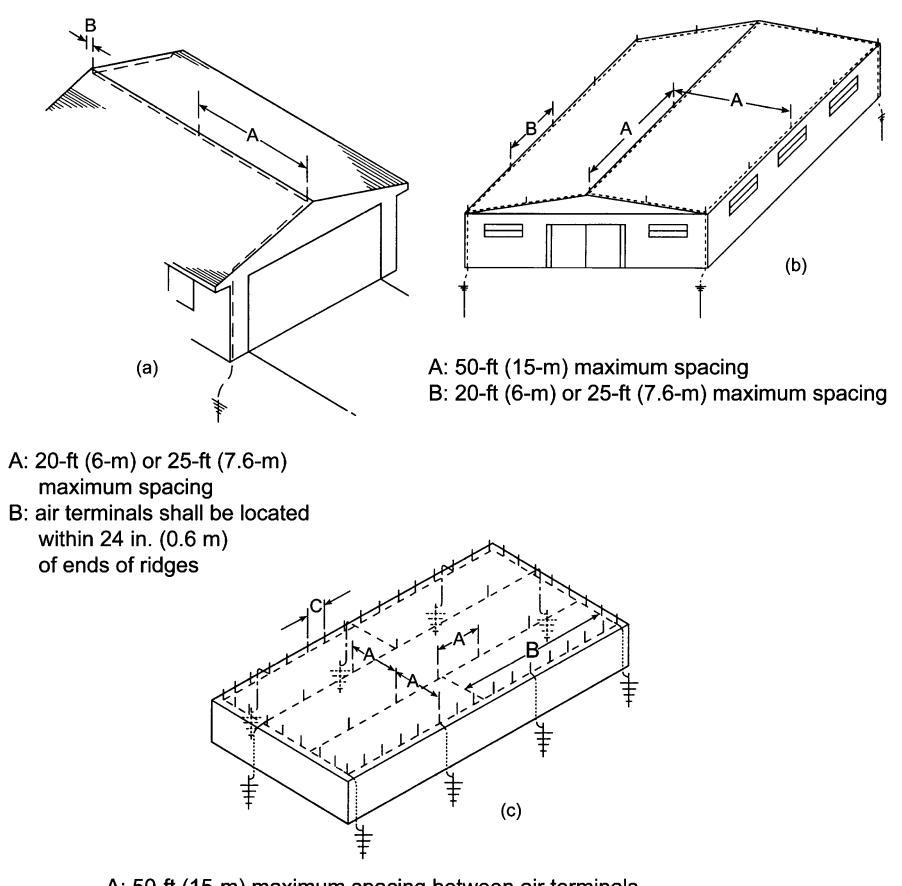
A: 50-ft (15-m) maximum spacing between air terminals B: 150-ft (45-m) maximum length of cross run conductor permitted without a connection from the cross run conductor to the main perimeter or down conductor C: 20-ft (6-m) maximum spacings between air terminals along edge

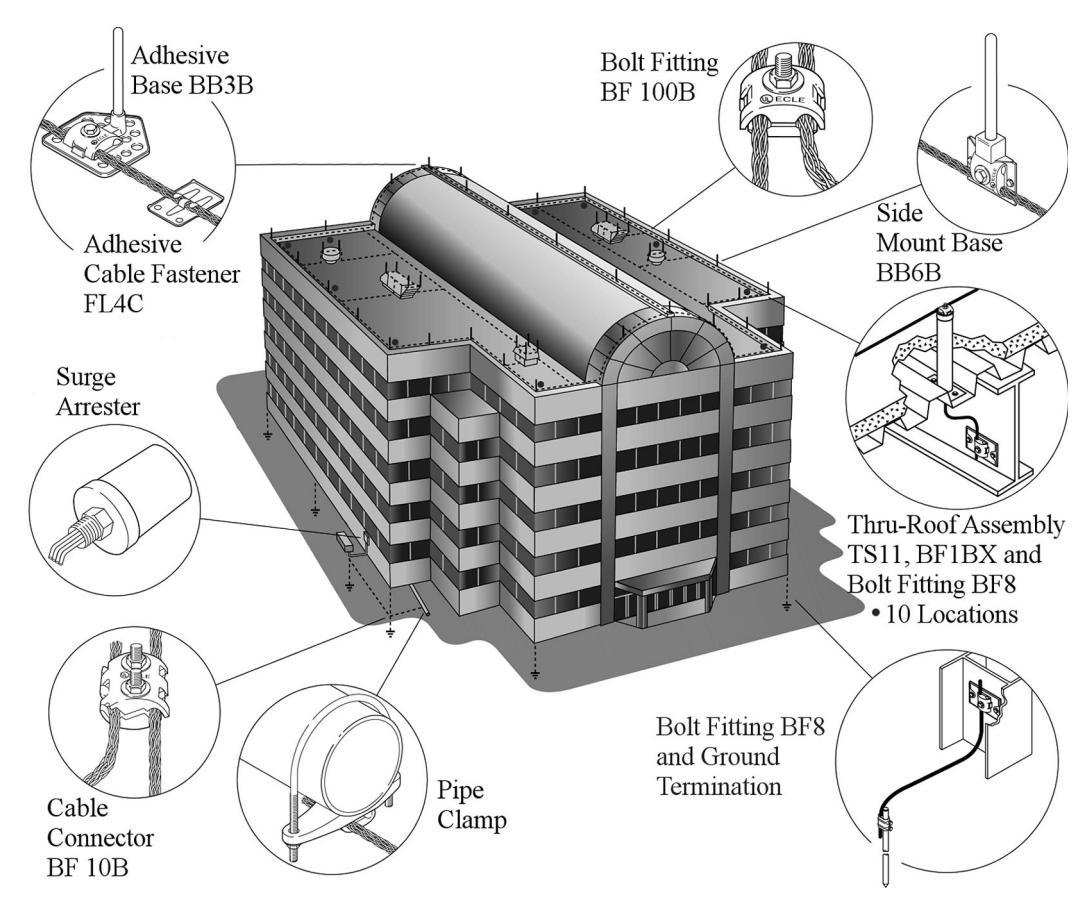
Fig. 3.5 Lightning protection of a commercial structure. Courtesy of East Coast Lightning Equipment, Inc.

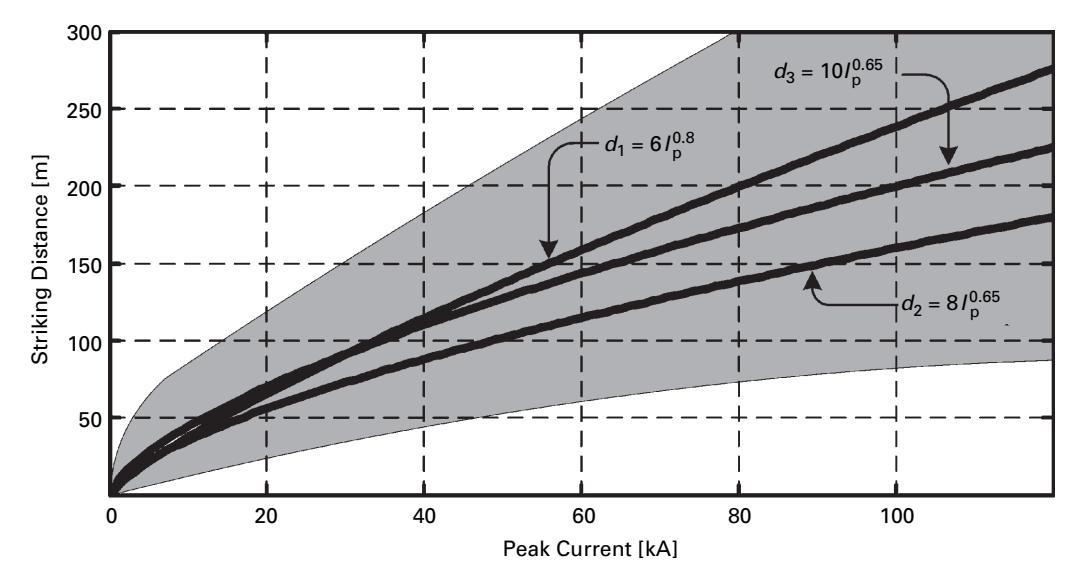
Fig. 3.6 Striking distance vs. first return stroke peak current for lightning to flat ground. Three common curves representing Eq. (3.2) with different values of the parameters *A* and *b* are plotted. The shaded region illustrates the approximate range of published calculations relating striking distance to peak current.

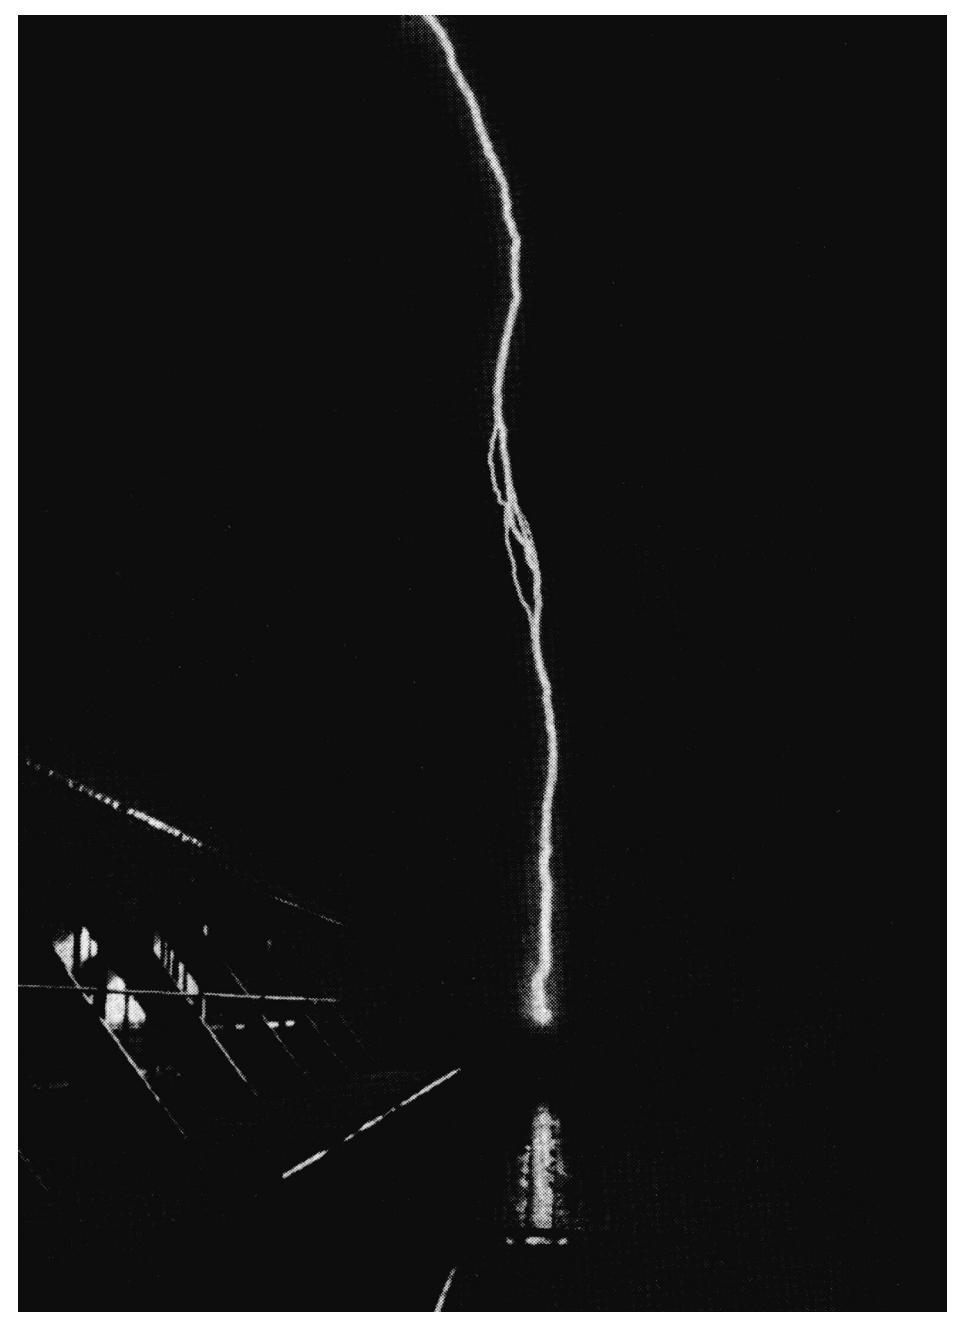
Fig. 3.7 A still photograph of a lightning strike to the unprotected chimney of a small building at the University of Helsinki. The loops in the lightning channel show the location where the upward and downward leaders connect. Taken from Golde (1973). Reproduced by permission of Edward Arnold (Publishers) Ltd.

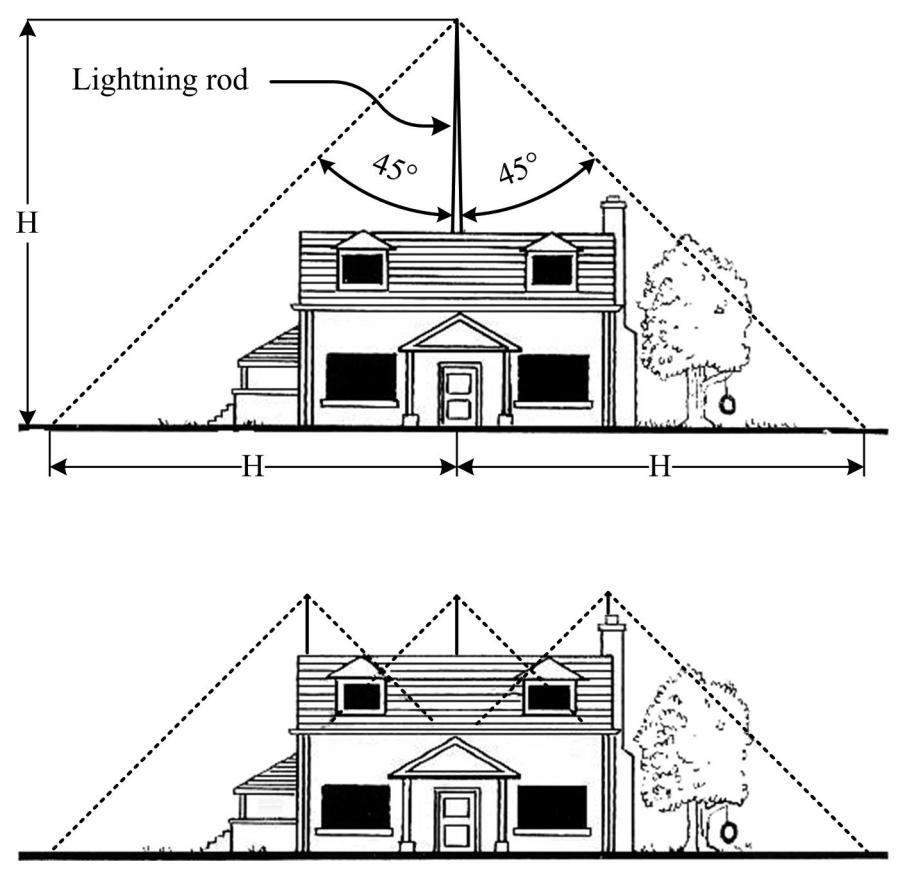
Fig. 3.8 The cone of protection method assuming a 45° cone with a single lightning rod (top), and multiple rods (bottom). Note that there are unprotected parts of the tree and, in the lower figure, of the roof that would, in theory, be protected if a 60° cone of protection had been assumed. Adapted from Uman (1986).

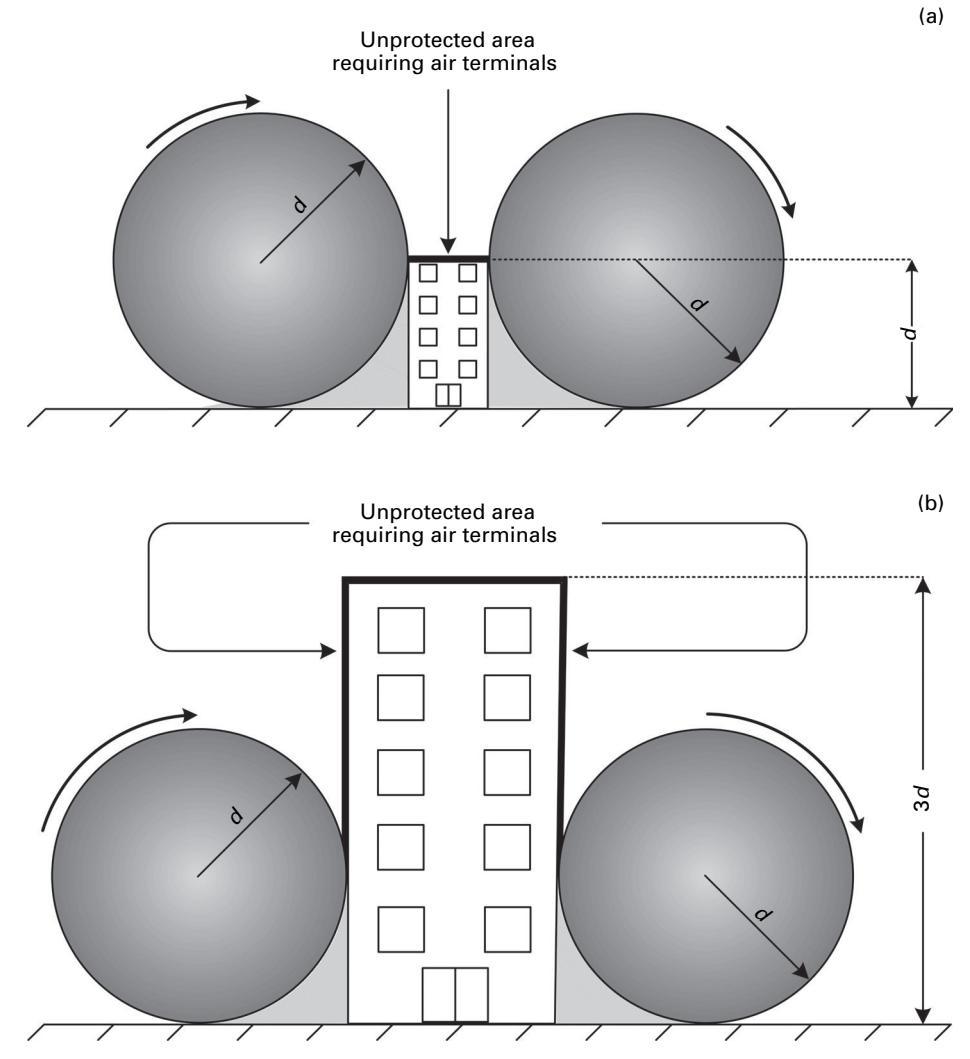
Fig. 3.9 Two examples of the application of the rolling sphere method. (a) The sphere is rolled over a structure whose height is equal to or less than the sphere radius (striking distance). The structure can only be struck by lightning on its top. (b) The sphere is rolled over a structure whose height is greater than the sphere radius (striking distance). The structure can be struck by lightning on its sides as well as its top. In both (a) and (b) the shaded volume is protected whereas the darkened surfaces on the structures may be struck.

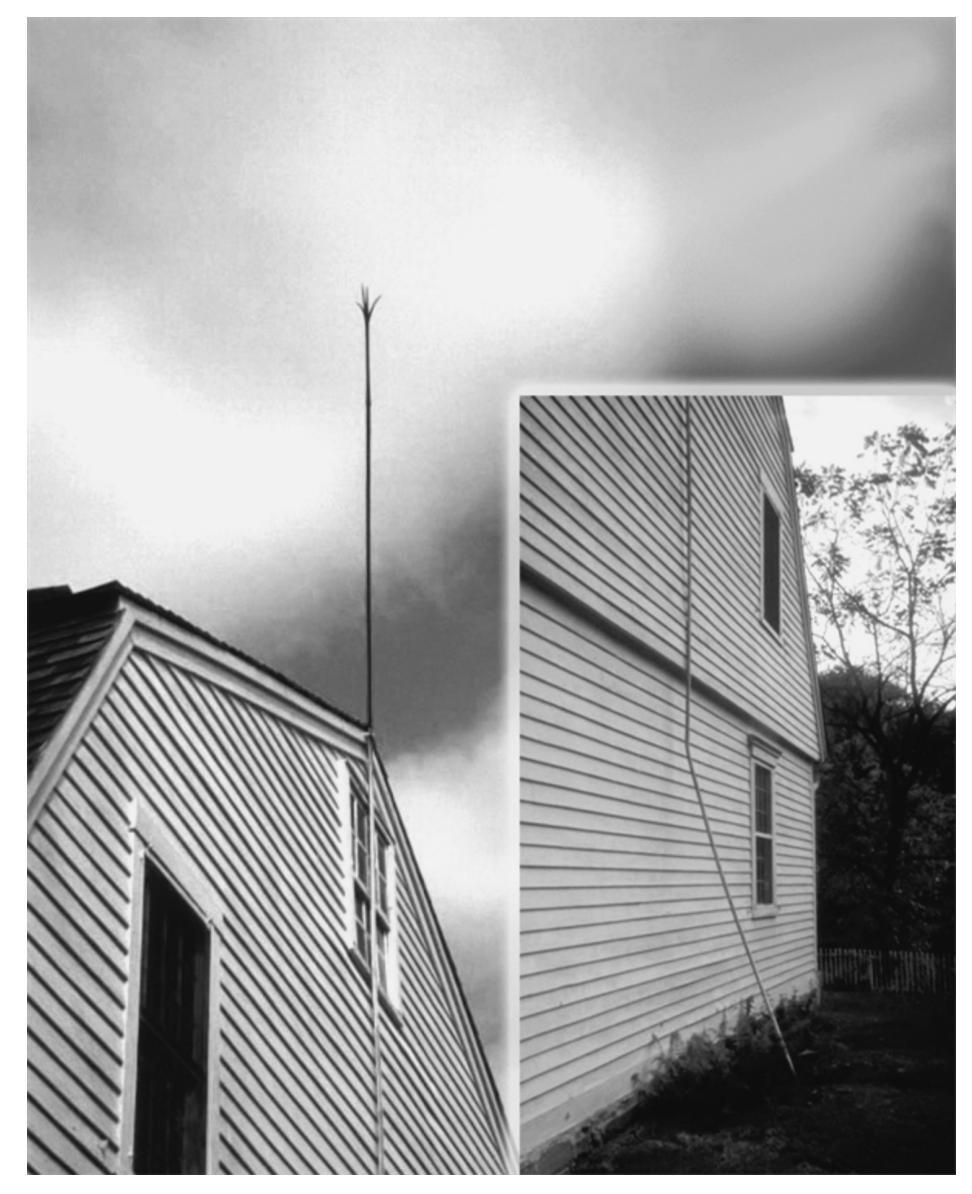
Fig. 4.4 An eighteenth-century house outfitted with a lightning rod of Benjamin Franklin's 1762 design. The rod continues downward as down conductor and grounding electrode. Courtesy of E. Philip Krider.

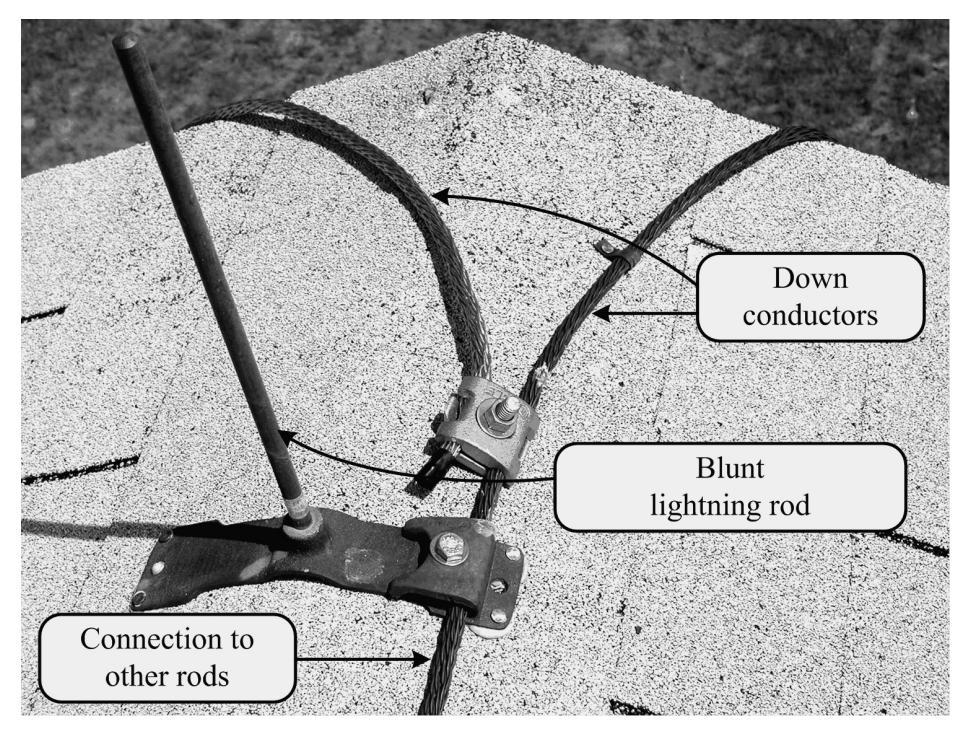
Fig. 4.5 A blunt-tipped lightning rod on the edge of a house roof. Two down conductors are attached, each leading to a grounding electrode on a different corner of the house. NFPA 780:2004 states that the lightning rod should be located within 0.6 m (2 feet) of the edge of the roof. Photograph by Brian De Carlo.

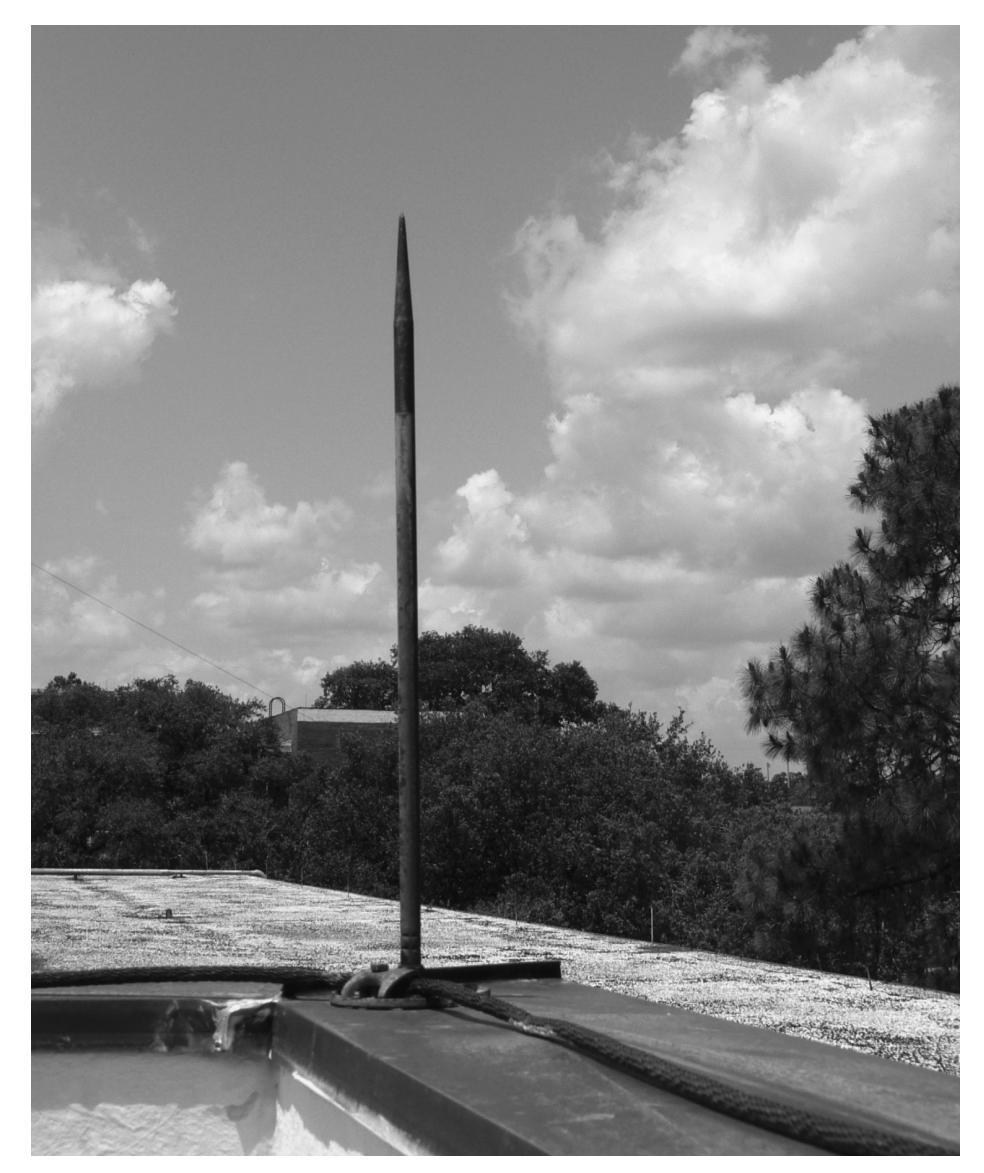
Fig. 4.7 A sharp-tipped rod on the roof of Benton Hall at the University of Florida. Note the stranded cable bonding the rod to all other rods on the roof and to the down conductors. Photograph by Keith Rambo.

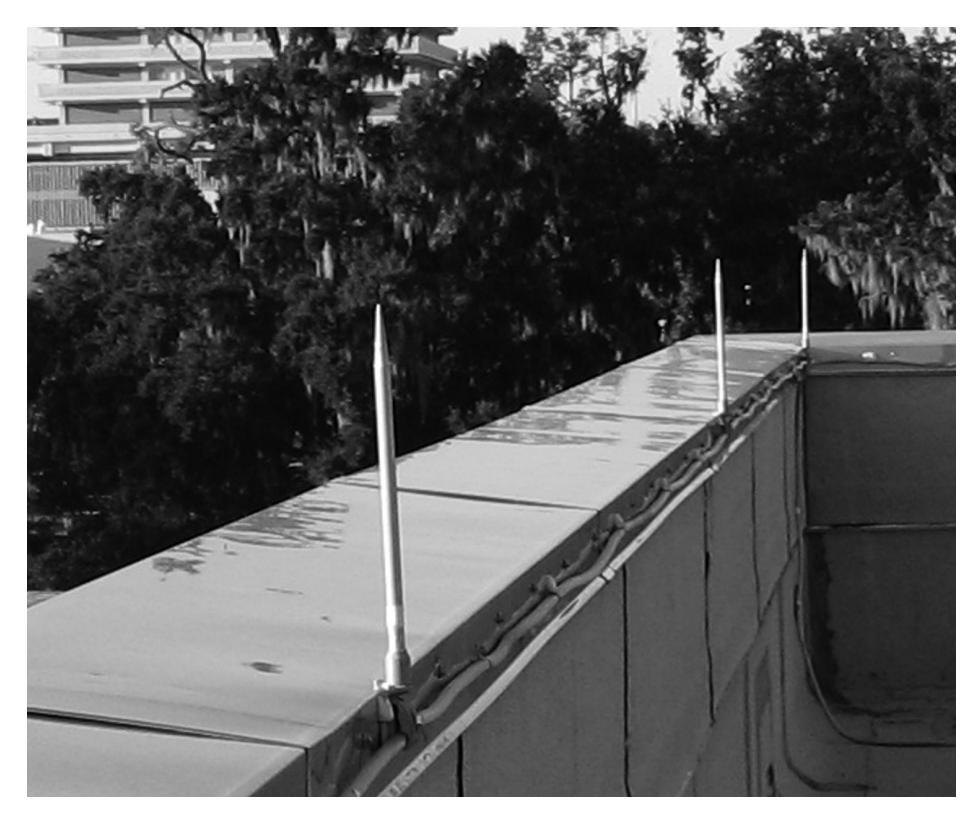
Fig. 4.8 A sequence of sharp-tipped rods on the roof of the Engineering Building at the University of Florida. Note the stranded cable connecting all rods both together and to the down conductors. Photograph by Britt Hanley.

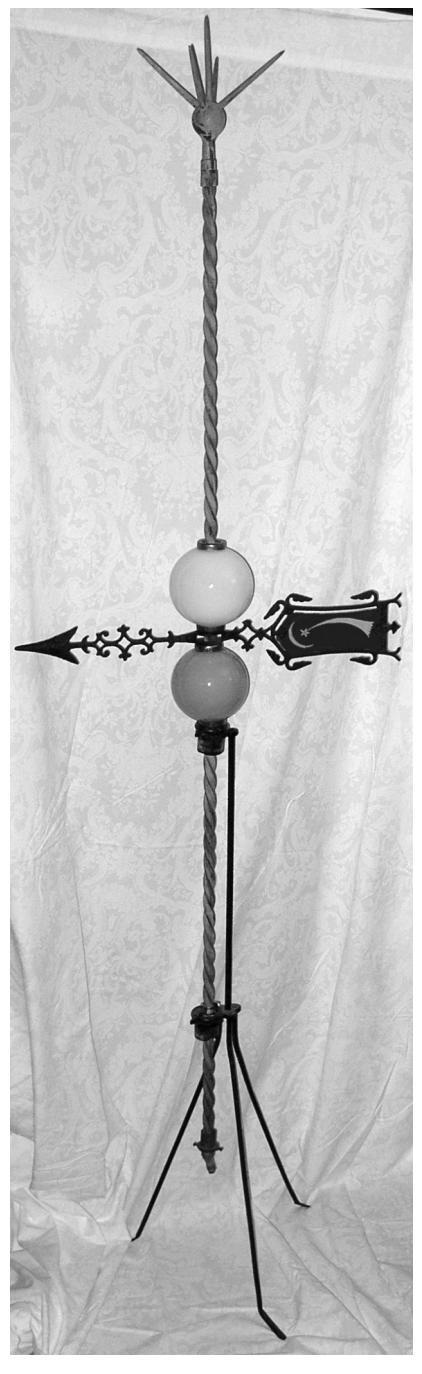
Fig. 4.9 A nineteenth-century rod that is about 2 m (over 6 feet) in height with a fancy tip (finial), ornamental glass balls, and an ornamental arrow with red glass insert. Photograph by Derek Uman.
