The Art and Science of Lightning Protection

Martin A. Uman

Martin A. Uman University of Florida

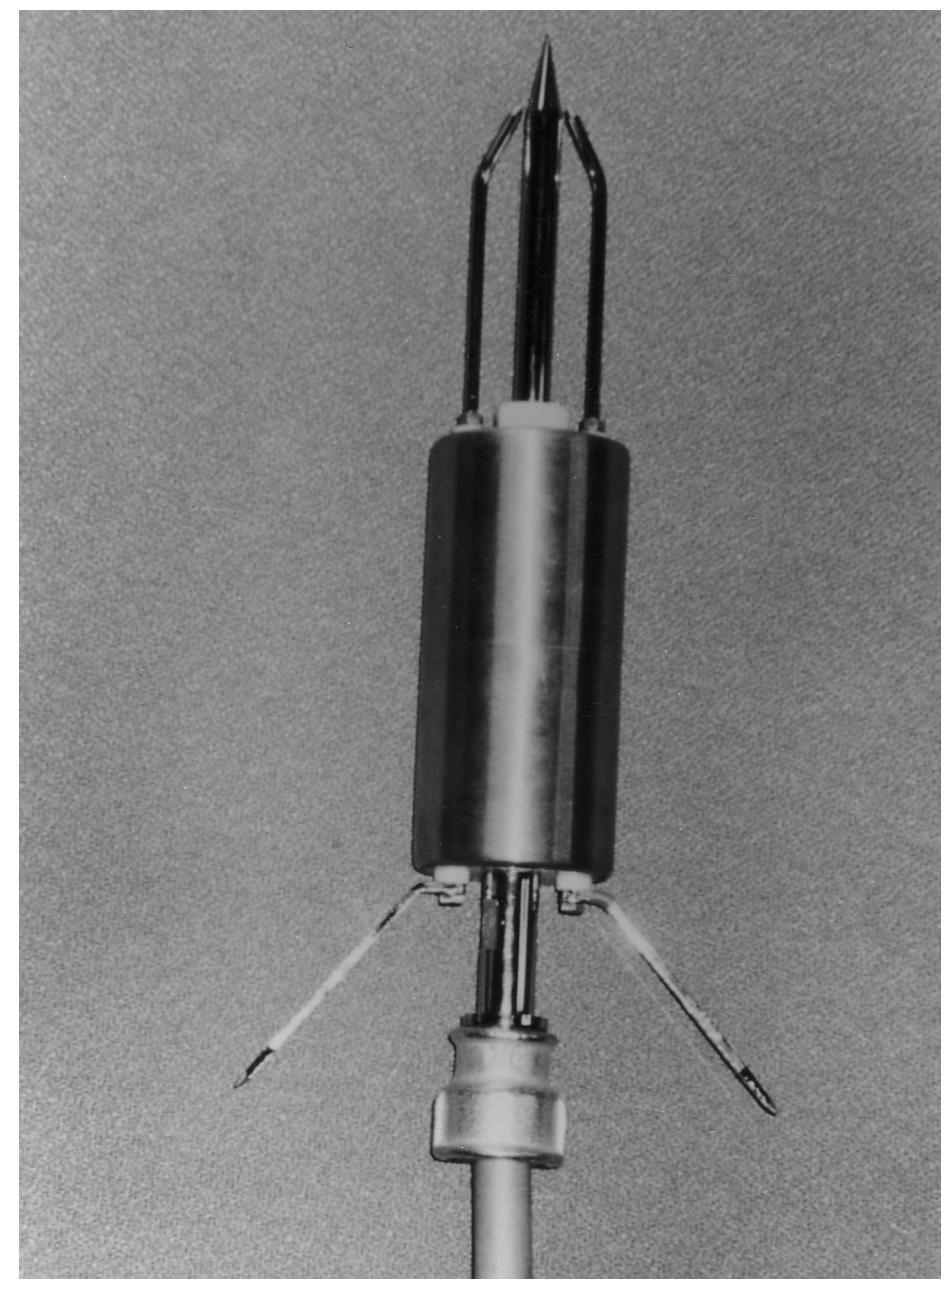
Fig. 4.10 A photograph of an "early streamer emission" air terminal.

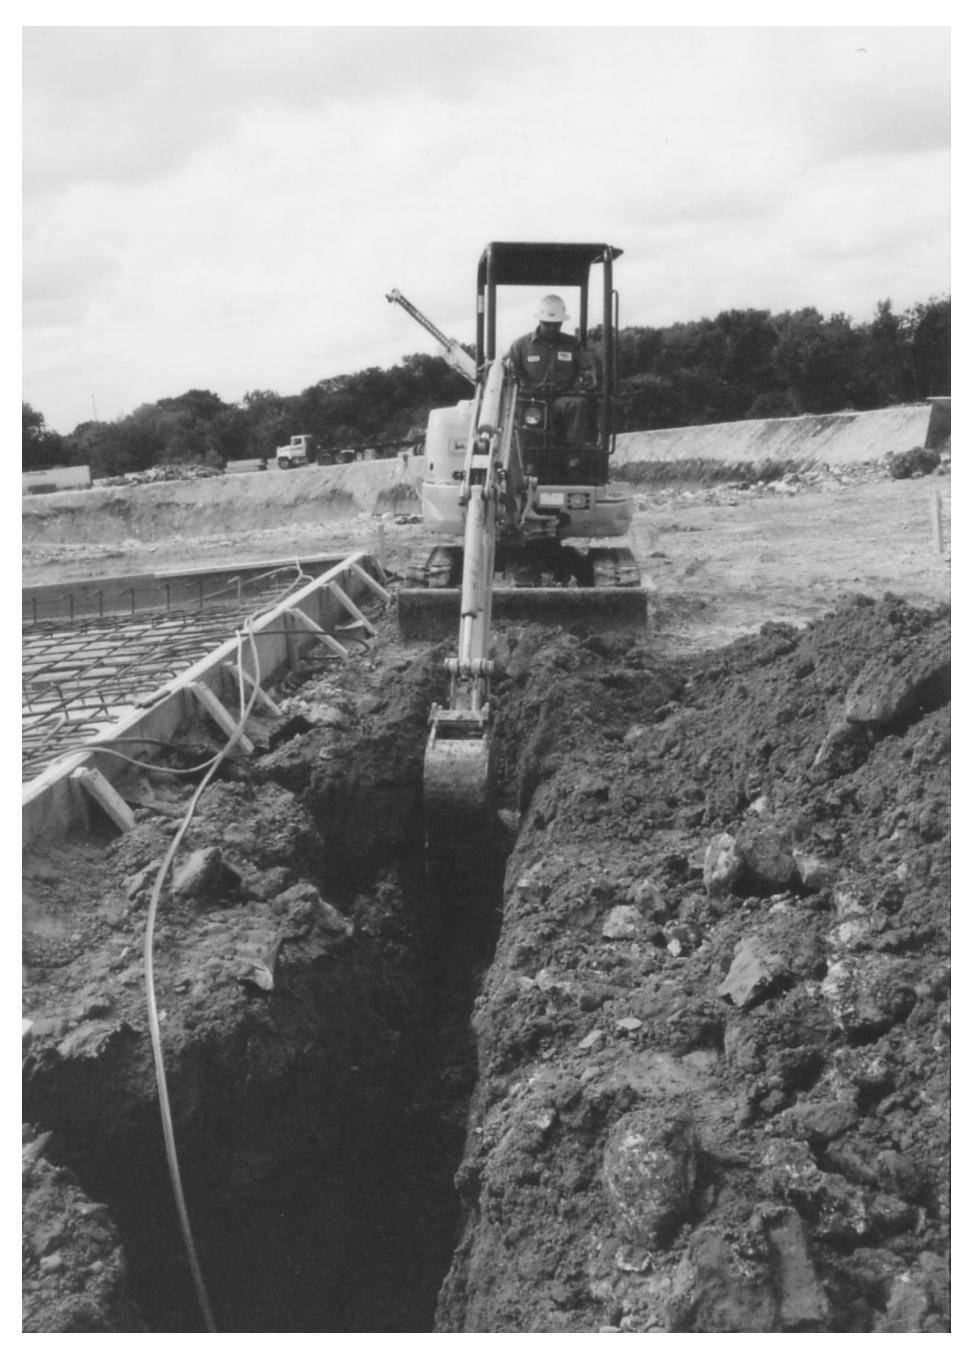
Fig. 5.1 A trench being dug to lay a ring electrode (counterpoise). The metal reinforcing bars (rebar) in the building foundation (left) are visible and form a metal mesh that is to be bonded to the ring electrode before cement is poured over the rebar. Courtesy of Bonded Lightning Protection, Inc.

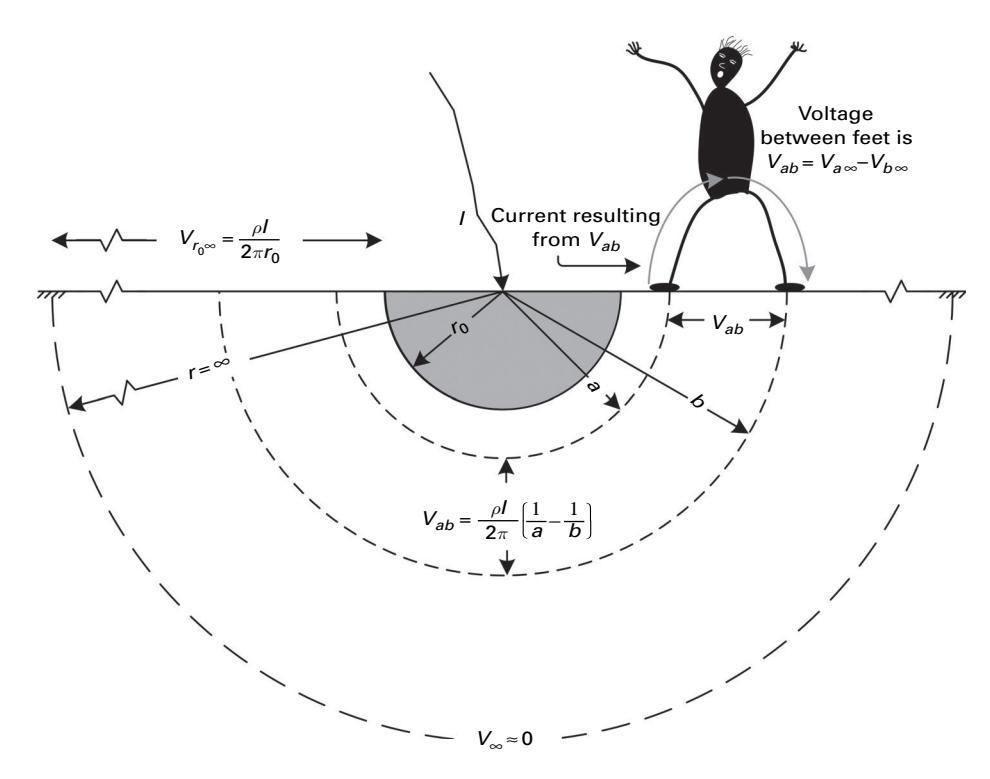
Fig. 5.3 The mechanism of step voltage for current injected into the metal hemisphere of Fig. 5.2. The dashed lines represent surfaces of equal voltage (potential), called equipotential surfaces.

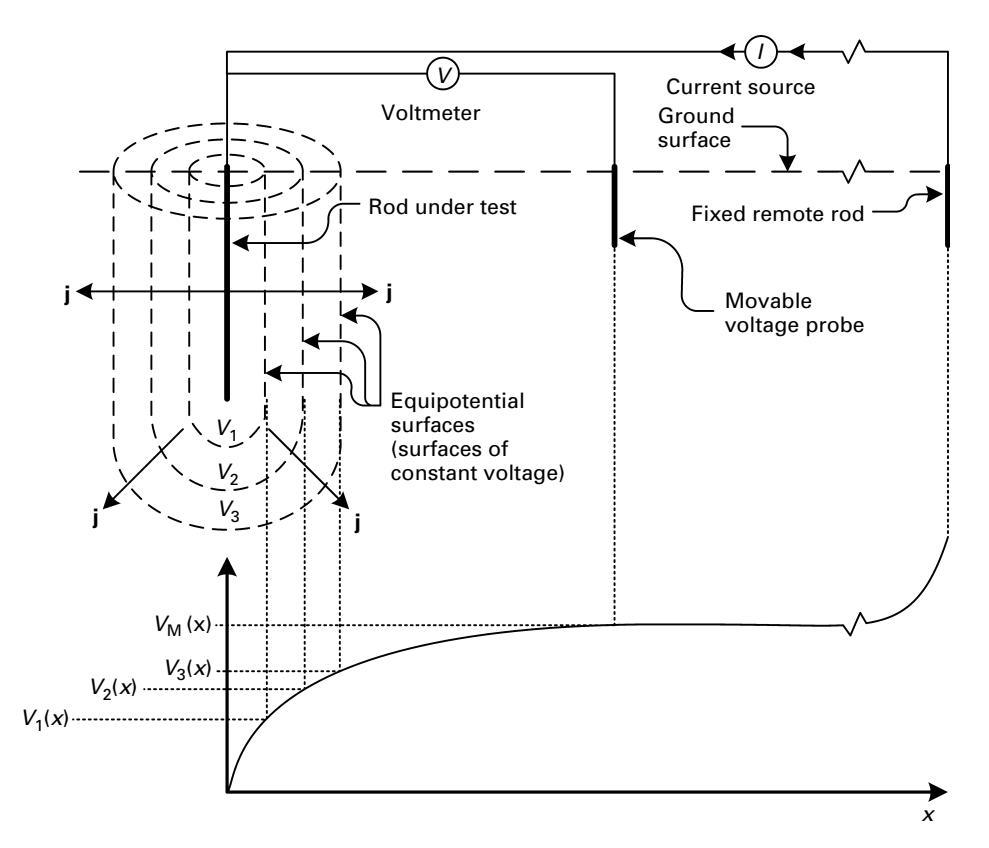
Fig. 5.4 The fall-of-potential method for measuring the grounding resistance of a ground rod.

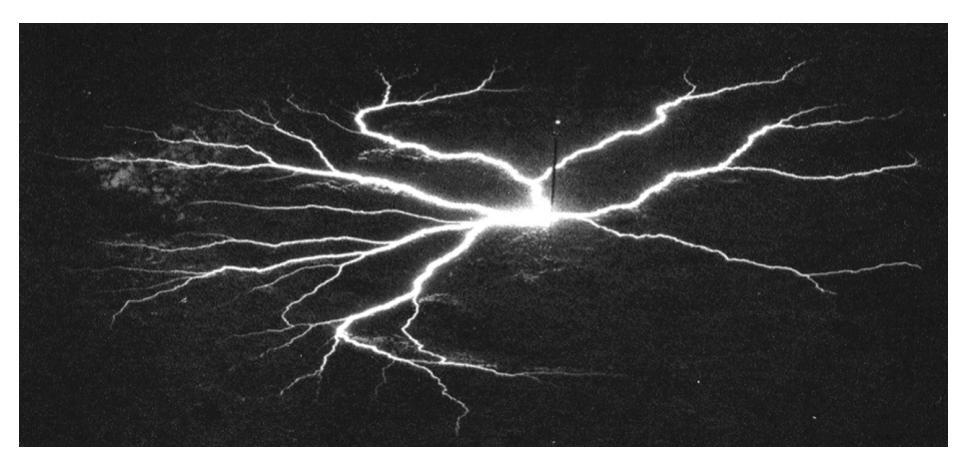
Fig. 5.5 Photograph of surface arcing of about 4 m radius from the point of current injection via a ground rod into soil in a laboratory experiment (Wang *et al.* 2005). Courtesy of Liew Ah Choy.

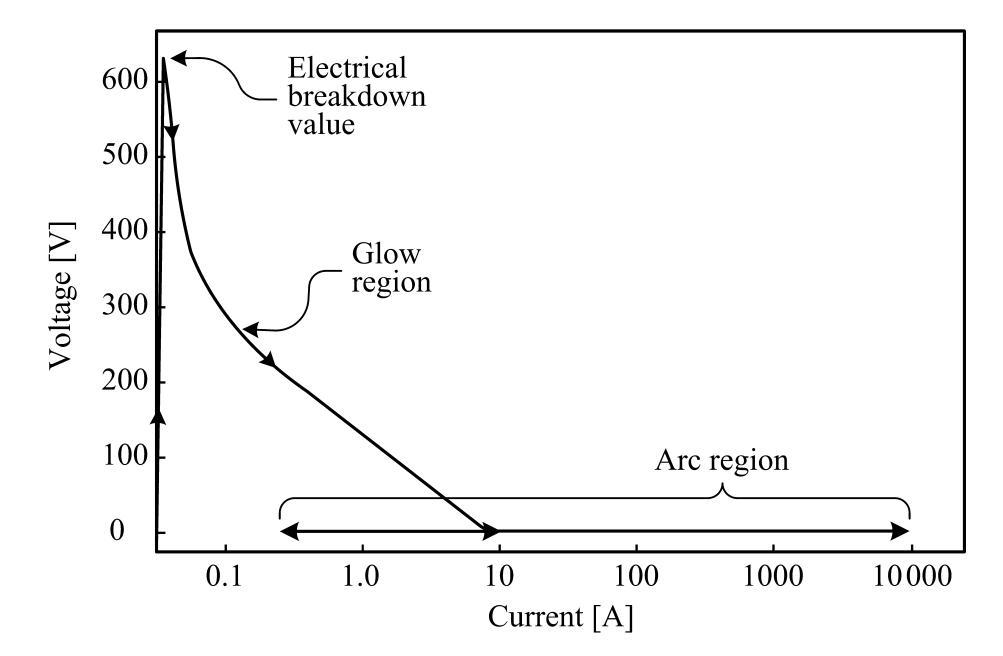
Fig. 6.3 Idealized voltage vs. current characteristic for a gas tube crowbar device.

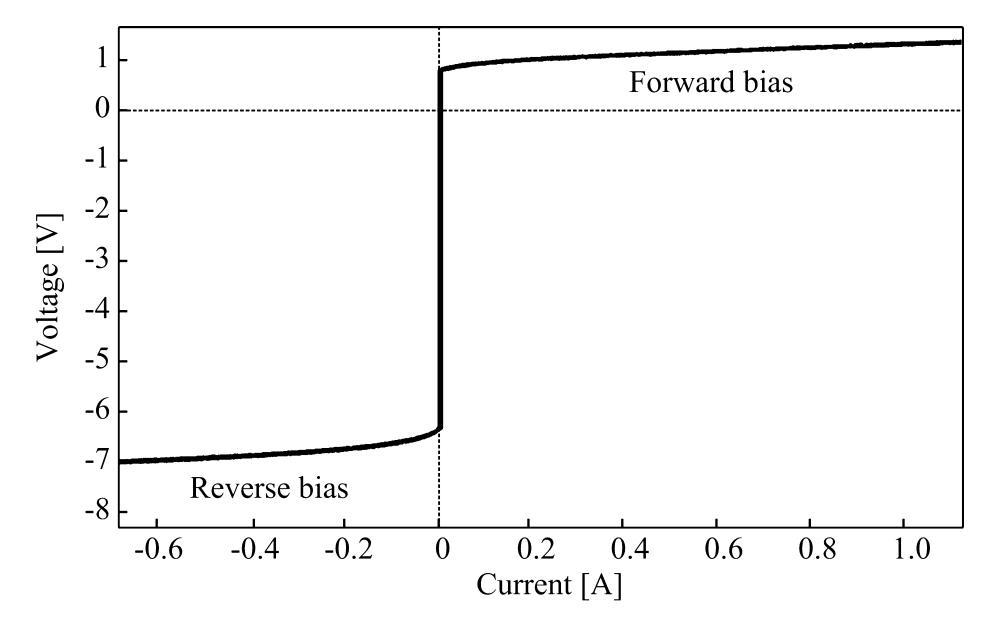
Fig. 6.5 Typical voltage vs. current characteristic for an avalanche diode.

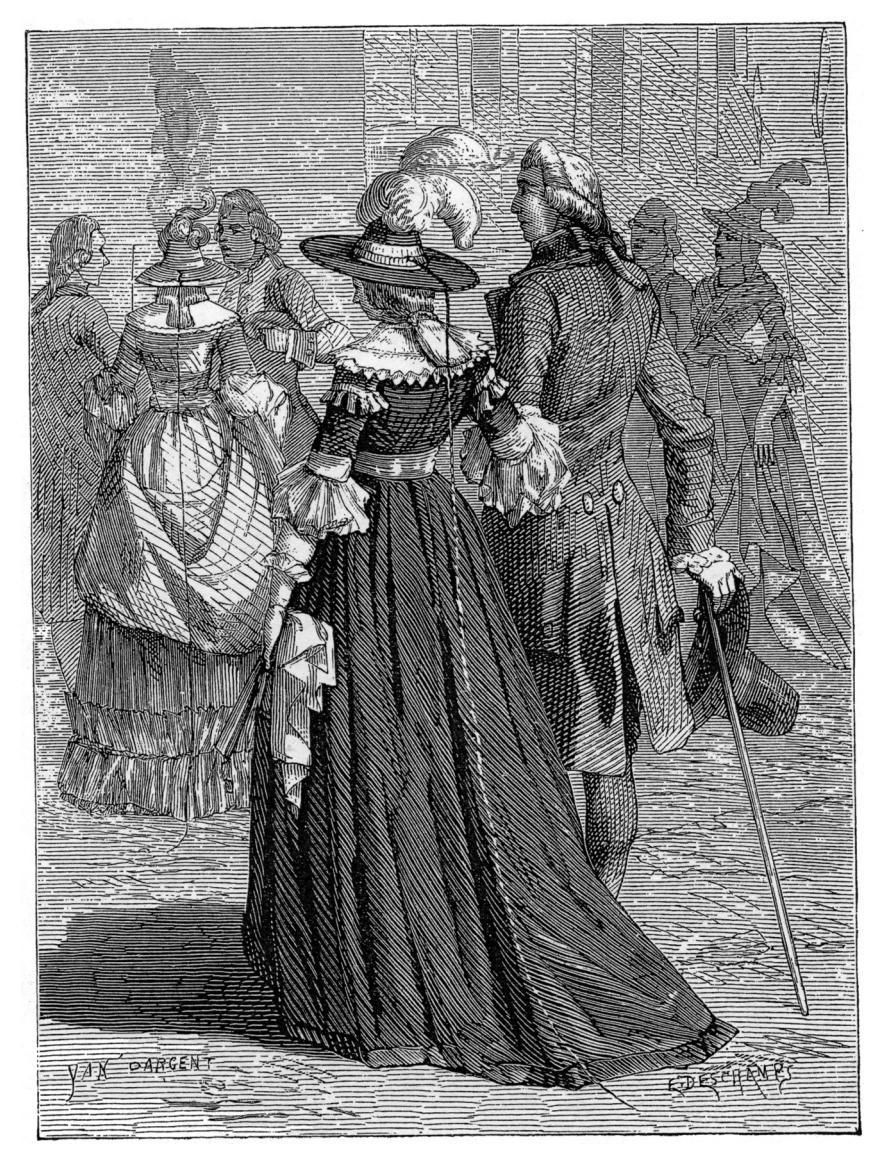
Fig. 7.10 An eighteenth-century personal lightning protection system proposed by Barbue-Dubourg. The air terminal is in the hat (bonnet) and the down conductor is grounded by contact with the Earth's surface. The etching is reproduced from the book by Figuier (1867).

A personal lightning protection system proposed to Benjamin Franklin by Jacques Barbue-Dubourg in a letter dated 1773. See Section 7.4 for more details.

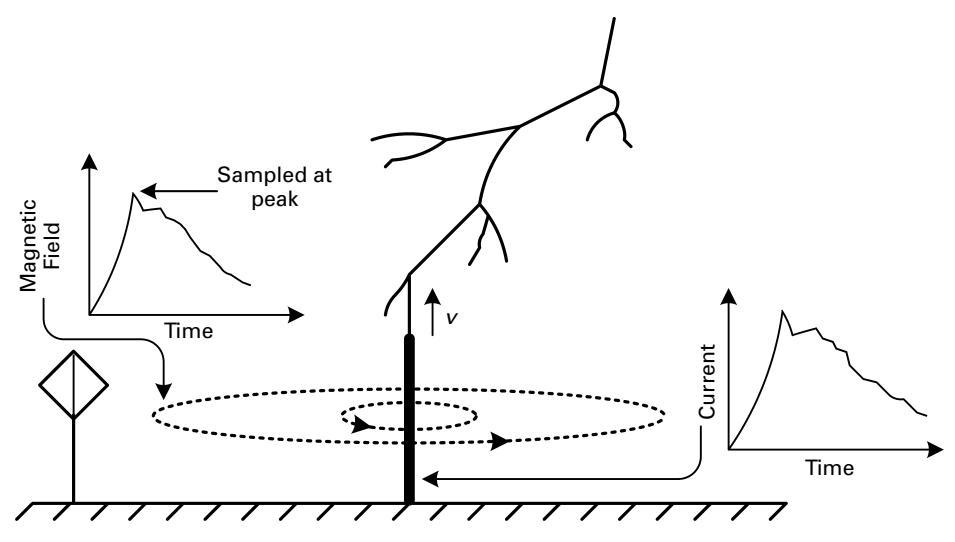
Fig. 8.5 The current in the developing return stroke channel and the radiated magnetic field during the first few microseconds of the return stroke. The return stroke propagates upward at speed *v* along a reasonably straight and vertical channel bottom.

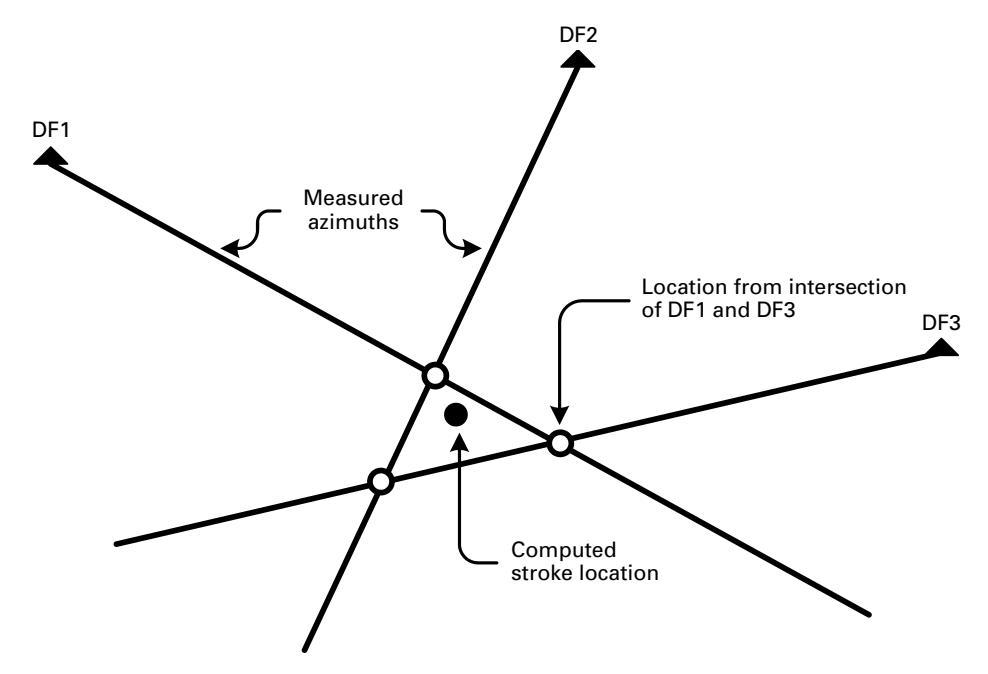
Fig. 8.6 Locating lightning from the intersection of three direction finding vectors.

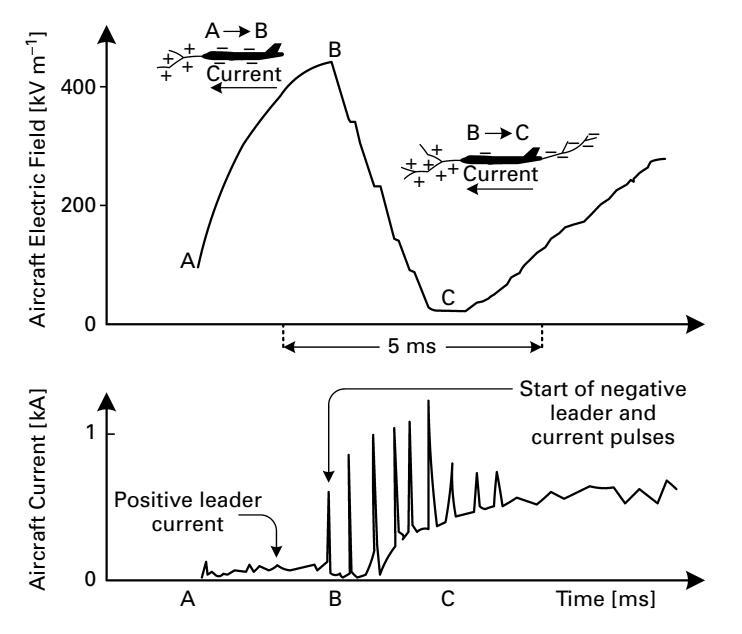
Fig. 9.2 An illustration of the mechanisms of lightning initiation by an aircraft in flight. Adapted from Lalande *et al.* (1999). Reprinted with permission from SAE paper 1999-01-2397 © 1999 SAE International.

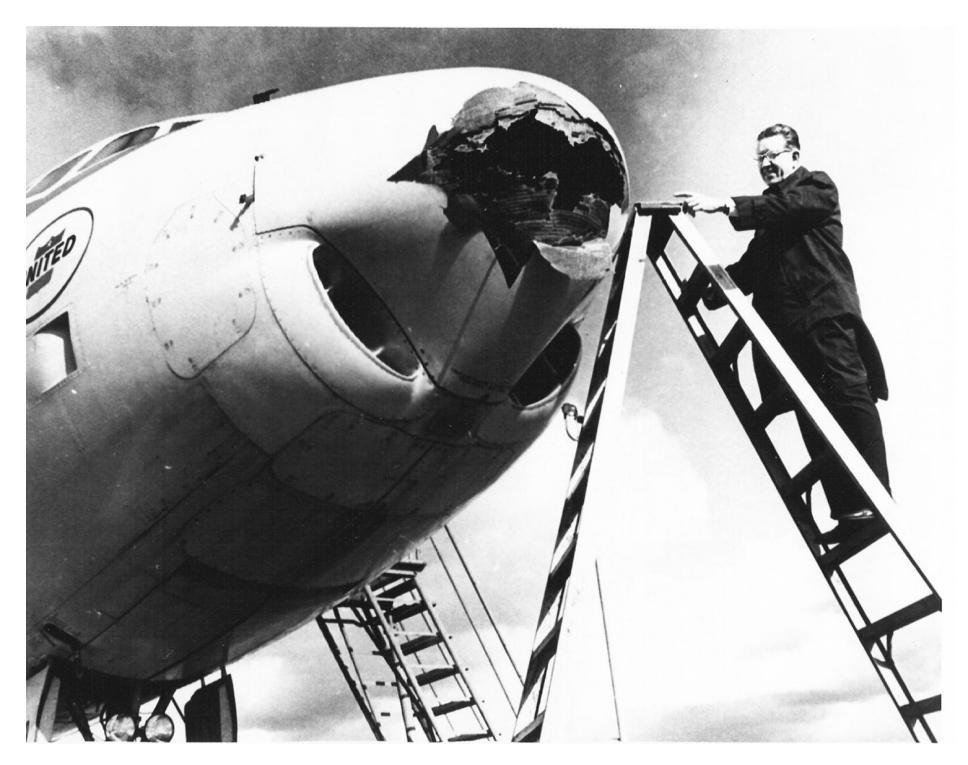
Fig. 9.6 Radome damage caused by a lightning strike to an aircraft near Los Angeles on January 28, 1969. Photo courtesy of the Los Angeles Times.

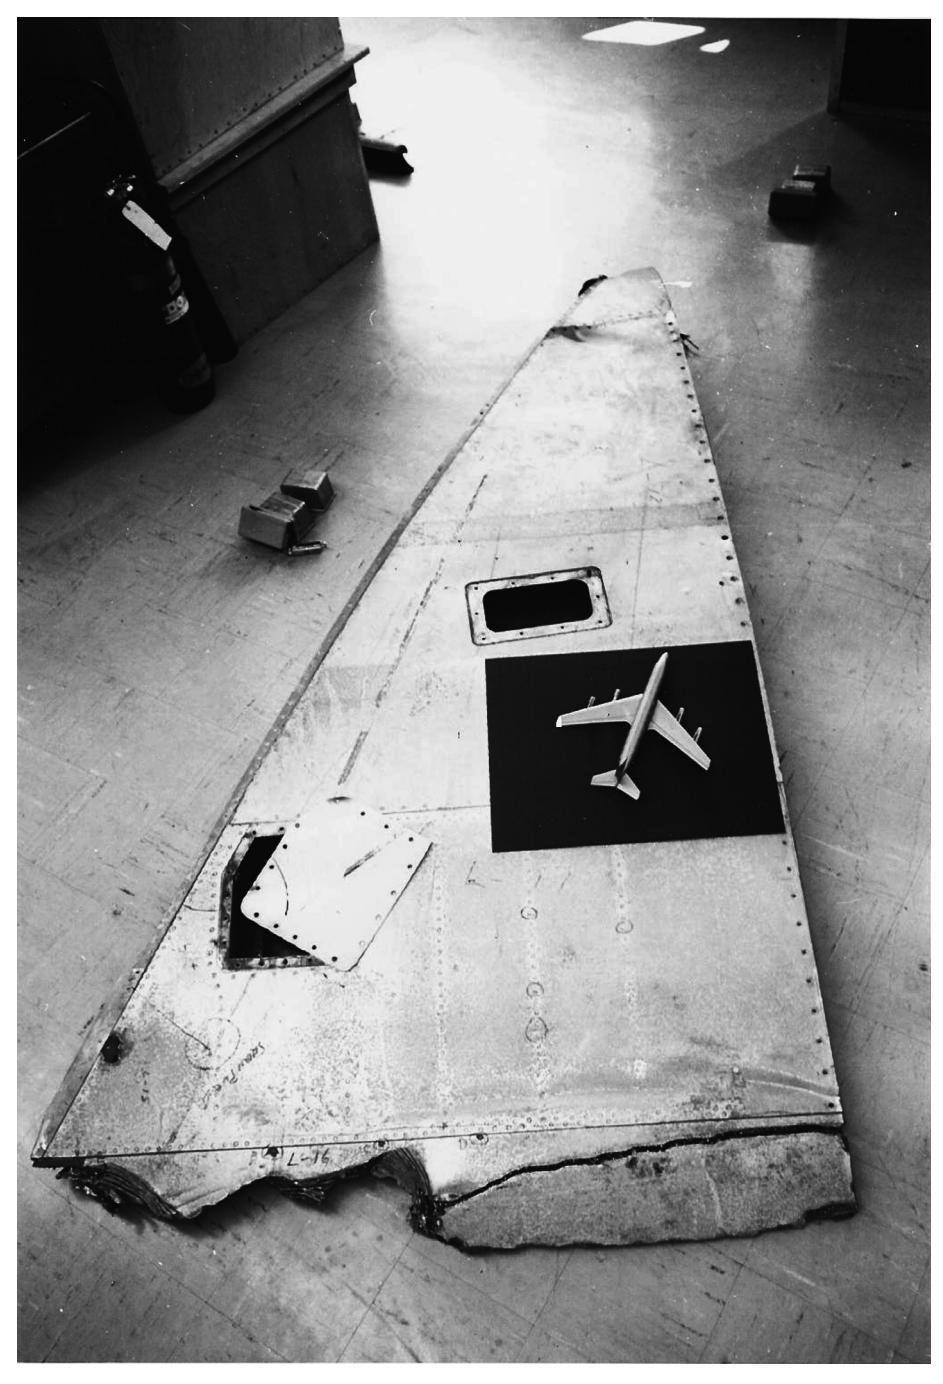
Fig. 9.7 Photograph of the left wingtip of the Boeing 707 that was destroyed by lightning on December 8, 1963, near Elkton, Maryland. On the model insert, the white portion of the wing gives the relative size and orientation of the portion of the actual wing shown. A number of lightning-caused holes and considerable pitting are evident. Courtesy of Bernard Vonnegut and Roger Cheng.

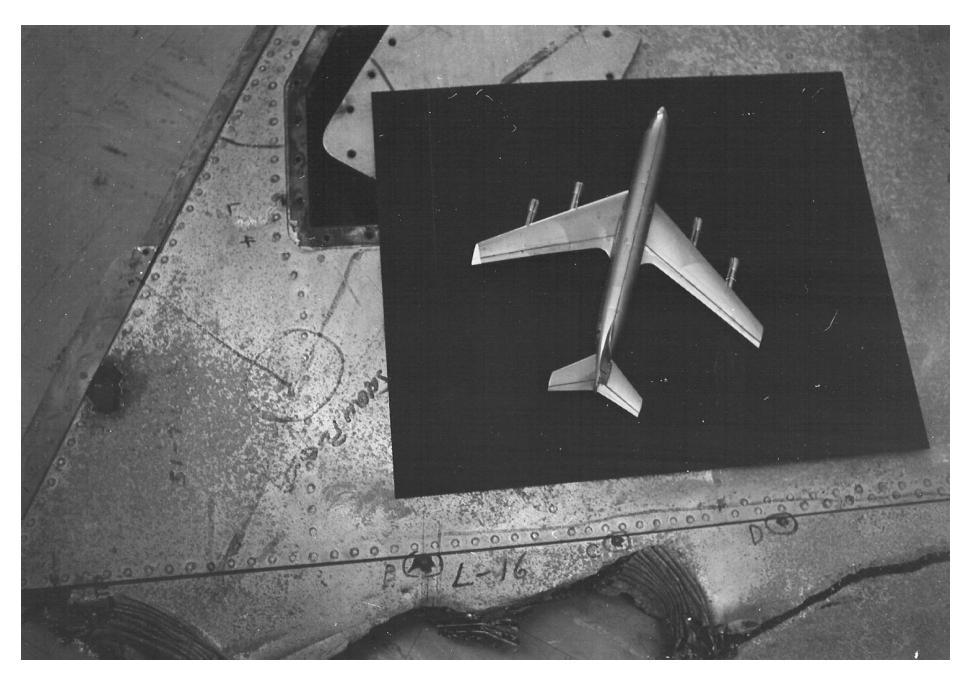
Fig. 9.8 A closer view of the Boeing 707 wingtip shown in Figure 9.7. Five lightning-caused holes are visible. Courtesy of Bernard Vonnegut and Roger Cheng.

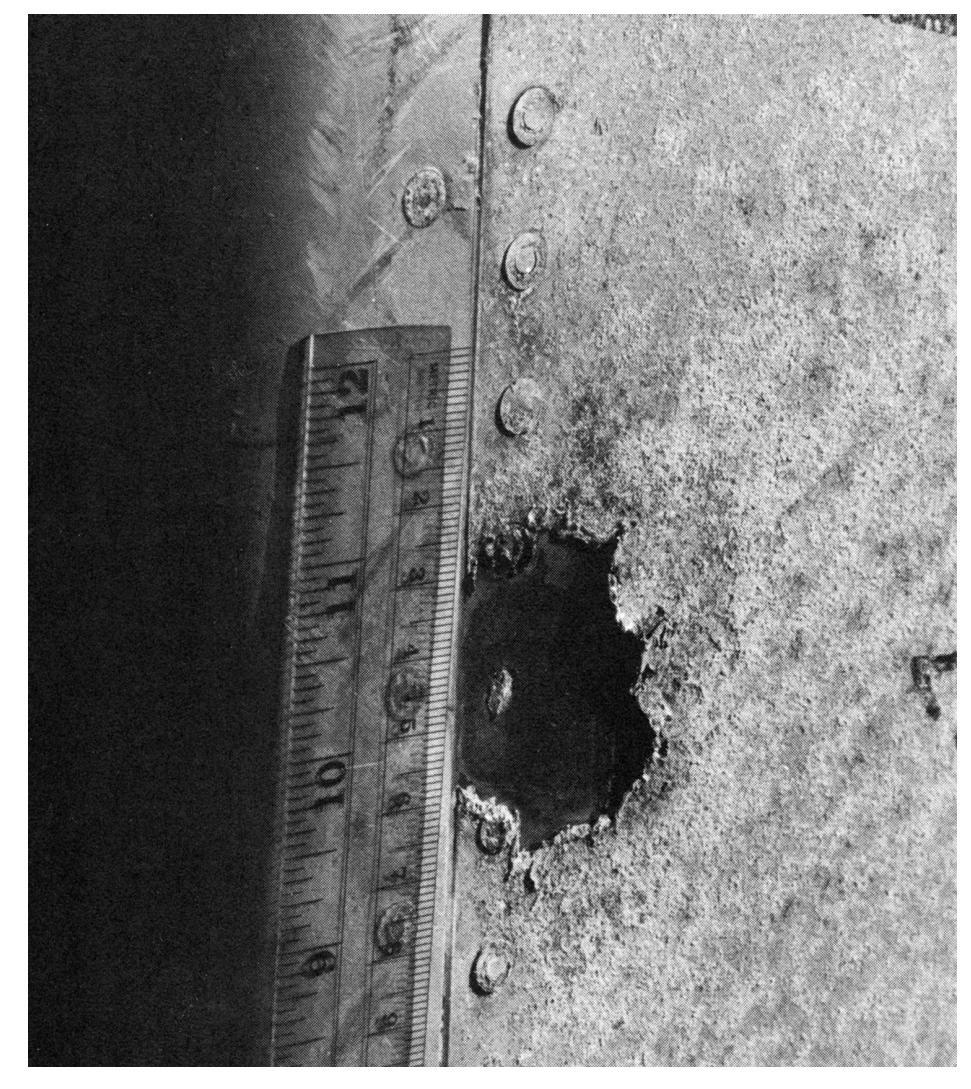
Fig. 9.9 An even closer view of the major wingtip hole and surrounding pitting seen in Fig. 9.7 and Fig. 9.8. Courtesy of Bernard Vonnegut and Roger Cheng.

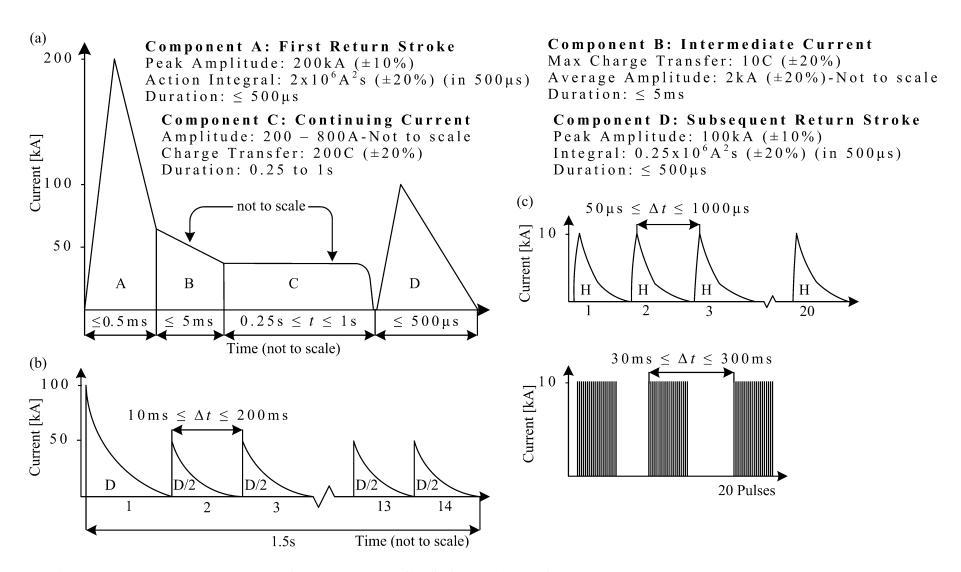
Fig. 9.10 Laboratory current waveforms specified for aircraft testing. (a) Current components A through D simulating the first two strokes in a cloud-to-ground flash, (b) multiple-stroke waveform simulating the second and additional strokes, and (c) multiple-burst (H-component) waveform showing the pulse waveshape (top) and pulse burst structure (bottom). Reprinted with permission from SAE ARP5412 Revision A © 2005 SAE International.

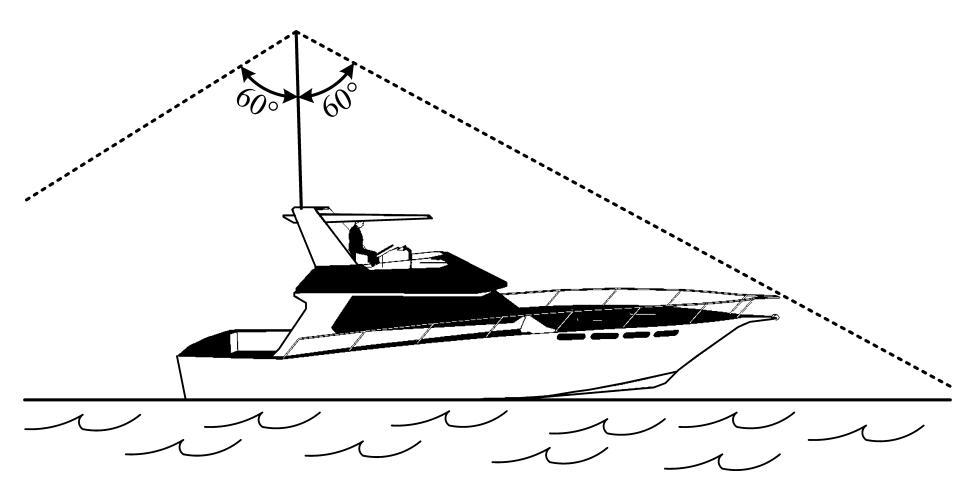
Fig. 10.3 A powerboat protected by a grounded vertical conducting mast that is assumed to provide a 60° cone of protection. The vertical mast, the air terminal, may be designed to be removable and used only when thunderstorms are present.

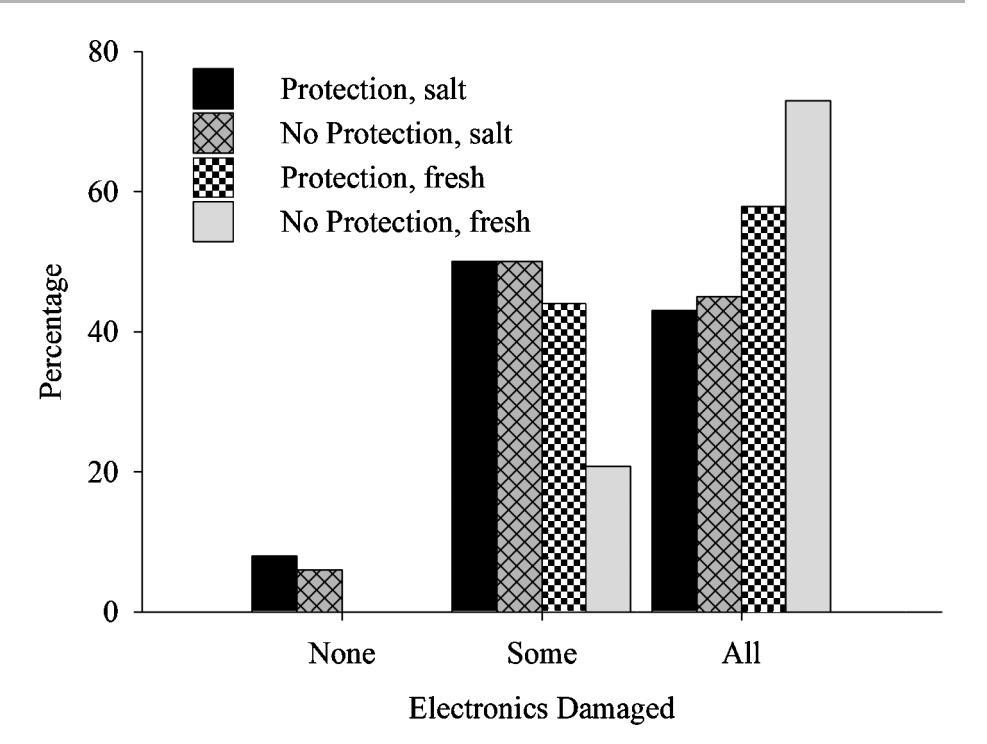
Fig. 10.4 Frequency distribution for proportion of boats with electronics systems that had none, some, or all of their electronics systems damaged as a result of a direct lightning strike. Adapted from Thomson (1991).

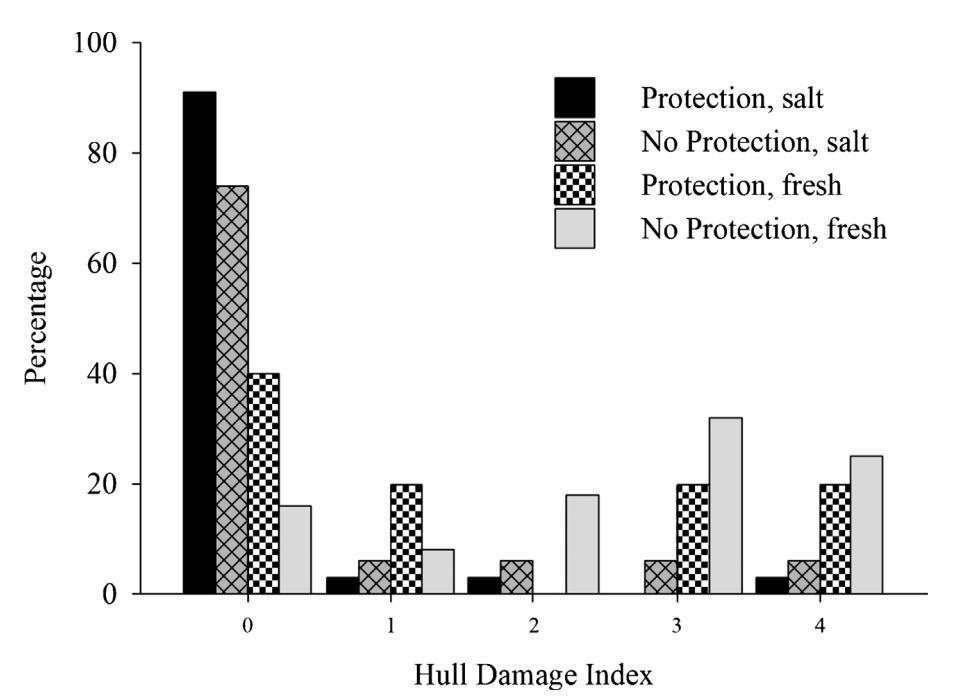
Fig. 10.5 Frequency distribution for the proportion of boats that incurred hull damage, on a 0 to 4 scale, as a result of a direct lightning strike. The index values are defined in the text. Adapted from Thomson (1991).

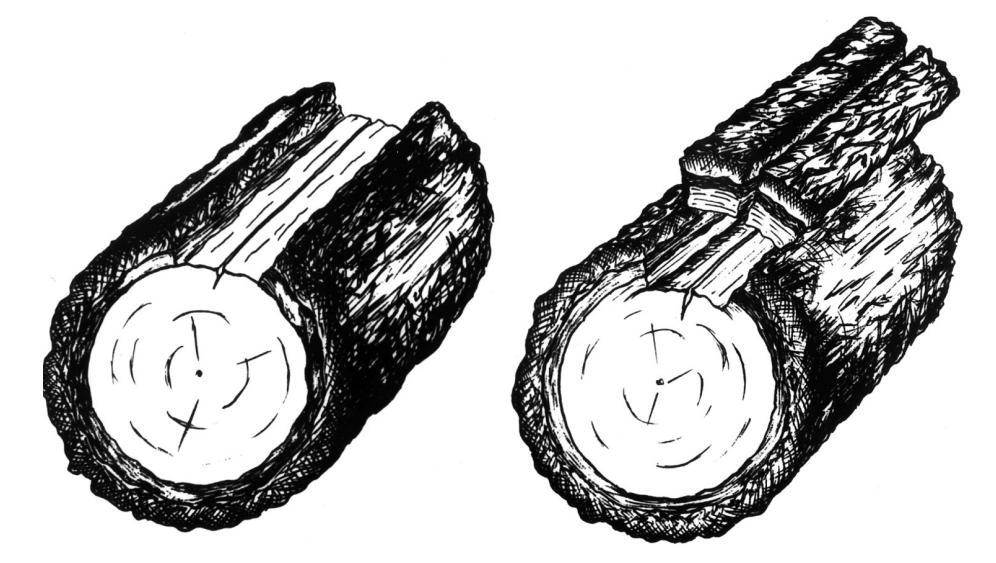
Fig. 11.7 Drawing of the formation of a lightning-caused tree scar as shown in Fig. 11.5 and Fig. 11.6. Courtesy of A. R. Taylor.

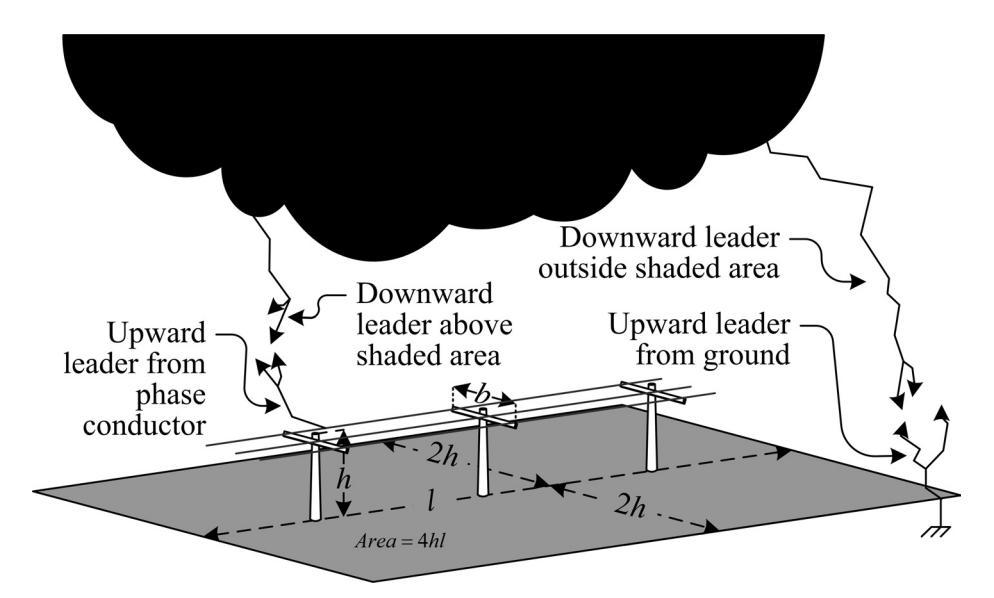
Fig. 12.1 A drawing illustrating the calculation of the number of lightning flashes striking an overhead power line. The equivalent collective area is shown shaded.

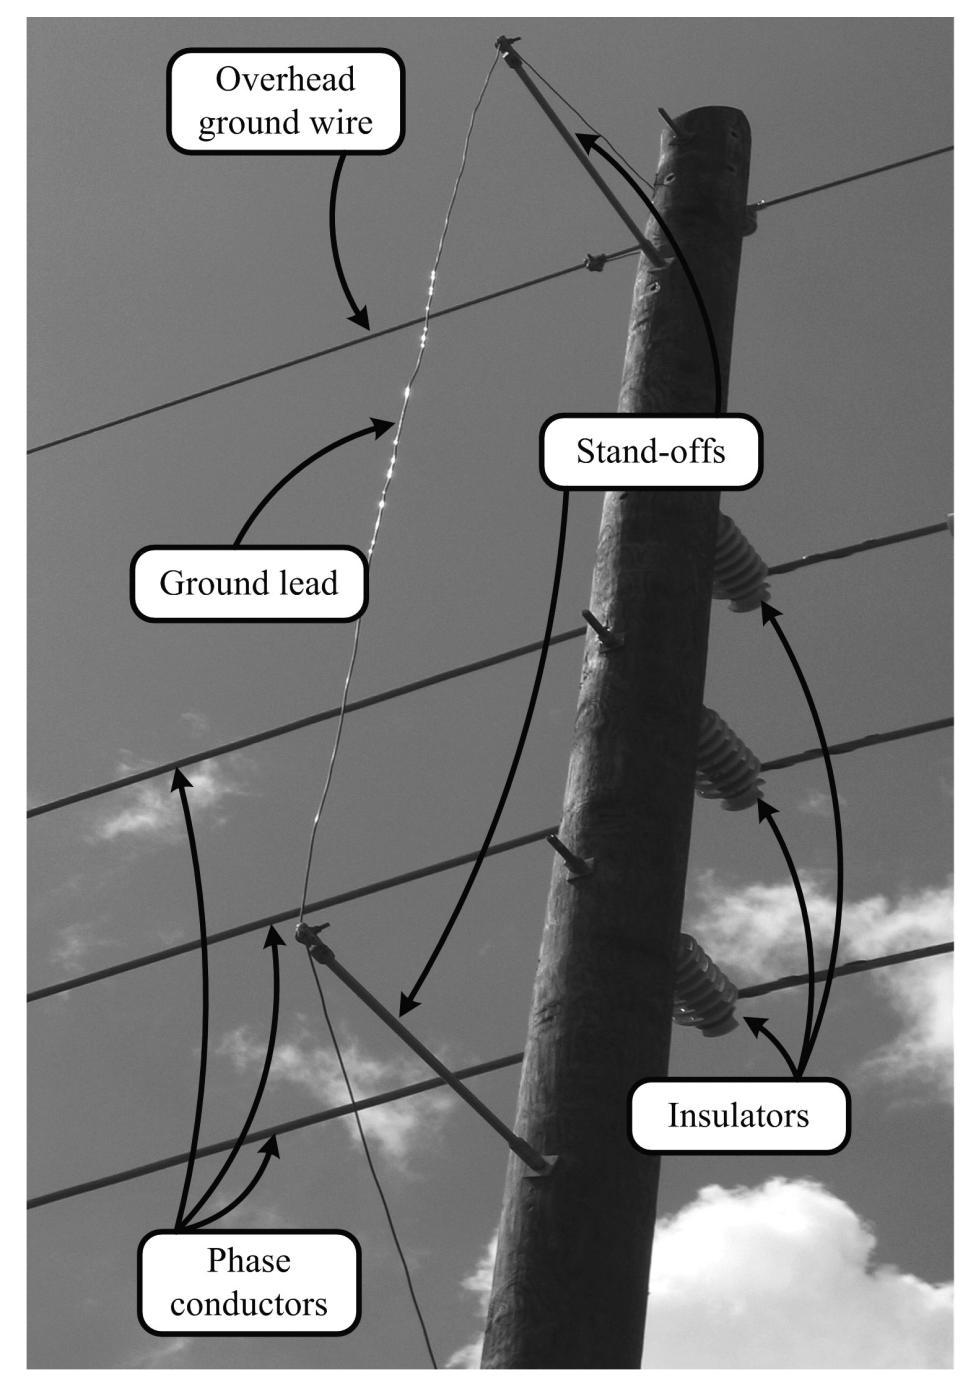
Fig. 12.3 An overhead ground wire protecting the phase wires of a wood-pole distribution line in Florida. The down conductor is routed into the air around the vertically configured phase conductors to provide greater insulation against a flashover between the overhead ground wire/connected grounding system and the phase conductors. Photograph by Jens Schoene.

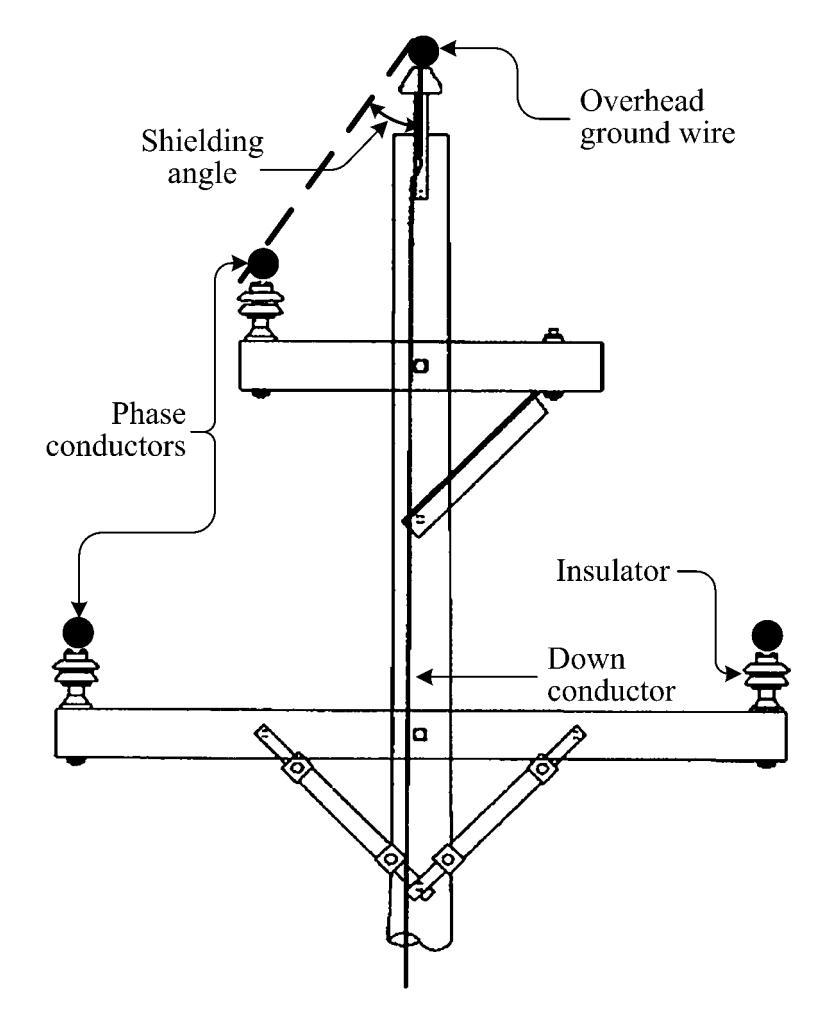
Fig. 12.5 An illustration of the "shielding angle" that the overhead ground wire provides for the phase conductors of a power line. Adapted from IEEE Standard 1410:2004. Copyright © 2004 IEEE. All rights reserved.
